Evaluation of 5 years' performance of VIPs in a retrofitted building façade

Pär Johansson*, Bijan Adl-Zarrabi, Angela Sasic Kalagasidis

Department of Civil and Environmental Engineering, Chalmers University of Technology, SE-412 96, Gothenburg, Sweden

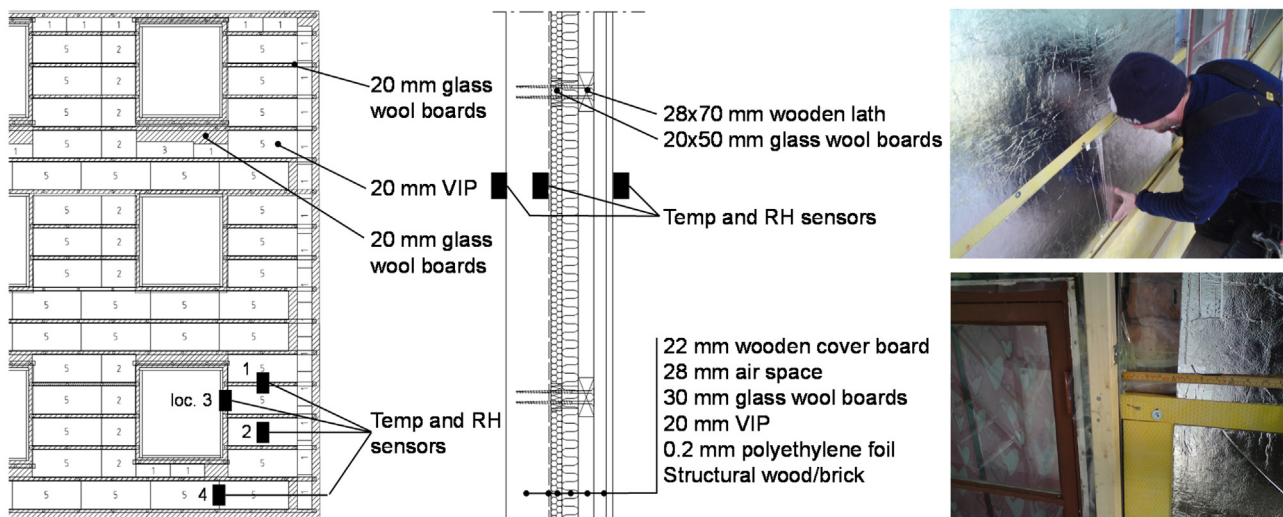
Fig. 3. Left: wall layout after retrofitting with 20 mm VIPs and 30 mm glass wool boards. The location of the temperature and RH sensors in the wall are marked by the black boxes (not in scale); 1) behind the strips of mineral wool, 2) behind the center-of-panel, 3) at the window frame, 4) behind the VIP–VIP joint. Right: installation of the VIP layer with the glass wool boards creating a thermal bridge between the VIPs themselves and between the VIPs and windows.

The temperature and RH is measured in 4 different locations in each of the two case study walls see Fig. 3 (left). In the ground floor wall, two sensors monitors the thermal bridge behind the strips of

mineral wool (Fig. 3 left, loc. 1), one sensor is located behind the center-of-panel (Fig. 3, left loc. 2) and one at the window frame (Fig. 3 left, loc. 3). Approximately the same locations were chosen for the wall on the 2nd floor but one of the sensors at the strips of mineral wool were here instead installed behind the VIP–VIP joint (Fig. 3 left, loc. 4). The minimum, average and maximum RH for the 8 different locations in the walls and outdoors during 2011, 2012, 2013, 2014 and 2015 are presented in Fig. 5. Unfortunately, a number of the built-in sensors have stopped sending data. The sensor at the VIP–VIP joint on the 2nd floor stopped sending data already in September 2013, which means only 2 years of data are available for this location. The reason for this is unknown. The battery should last for 15 years with hourly data sampling [18]. However, there could be other reasons for the malfunction like sensors working at their maximum range leading to excessive energy use, that an old battery was installed or sensor production error. The sensor behind the center-of-panel in the 2nd floor wall stopped sending data in March 2015. This is unfortunate since the measurements behind the center-of-panel was used for the previous evaluation [9]. Furthermore, the sensor located at the window frame in the ground floor wall stopped sending data in November 2014, one of the sensors behind the strips of mineral wool in the ground floor

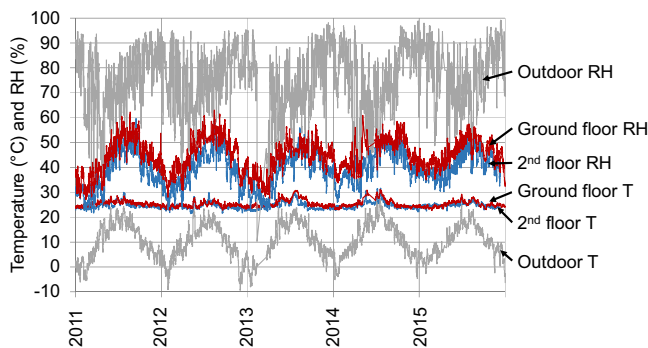
Fig. 4. Temperature and RH presented as the 24-h moving average in the apartments on the ground floor and 2nd floor, respectively, compared to the outdoor temperature and RH, for the period from January 2011, to December 2015.

It is clear that the temperature and RH in the two apartments is different throughout the 5 years. Both the temperature and RH is higher in the apartment on the ground floor than on the 2nd floor. Since the ground floor wall is made of brick and the 2nd floor wall is made of wood, the hygrothermal inertia is higher in the ground floor wall. This makes the daily variations lower in the apartment on the ground floor than on the 2nd floor. However, this does not explain the difference between the average temperature and RH. These are due to differences in the occupants' behavior which are virtually impossible to foresee. Therefore parametric studies of the design is needed before the construction is realized. In Table 1, the 5-year average temperature in the two apartments in the case study building is compared to two apartments in a neighboring reference

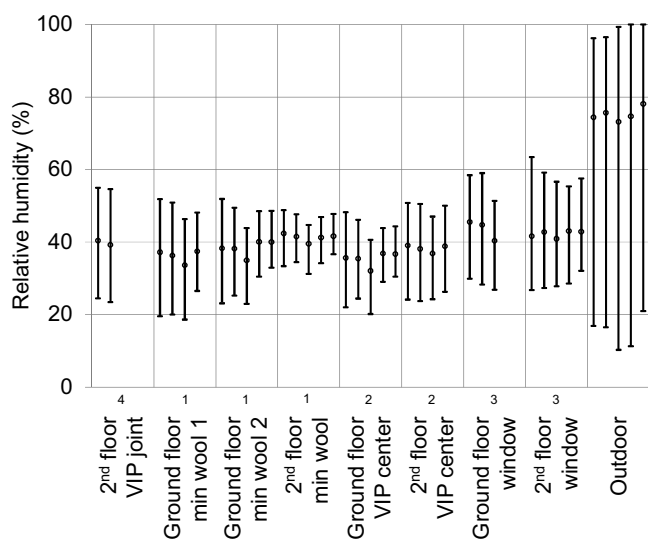
Fig. 5. The minimum, average and maximum RH at the 8 measurement locations in the walls and outdoors for 2011, 2012, 2013, 2014 and 2015. The numbers show the same locations in the ground floor wall and 2nd floor wall as defined in Fig. 3 (left). From left: 2nd floor VIP–VIP joint, ground floor mineral wool 1, ground floor mineral wool 2, 2nd floor mineral wool, ground floor center-of-panel, 2nd floor center-of-panel, ground floor window, 2nd floor window and outdoors.

The highest RH is found at the window locations both on the ground floor and 2nd floor. This is because of a lower temperature at these locations. The maximum yearly RH at the window on the 2nd floor was 63.4% in 2011 but has after that reduced and was 57.5% in 2015. The same result was found at the window locations on the ground floor. This could be due to built-in moisture due to exposure during the retrofitting which is drying out with time. For the other locations the maximum RH was between 48.2% and 55.0% while the minimum RH was between 18.6% and 31.2%. The difference between yearly minimum and maximum RH in the walls has decreased in the years following 2011. However, this is not the case for the indoor and outdoor air, which, as shown in Figs. 4 and 5, varies with the same amplitude. This means that for all the monitored locations, built-in moisture is drying out with time. For instance for the location behind the center-of-panel on the ground floor, the difference was 26.3 percentage points in 2011 and only 13.9 percentage points in 2015. When studying the absolute vapor content, the difference between maximum and minimum have not changed significantly between 2011 (6.9 g/m³) and 2015 (5.4 g/m³) but remains on the same level. For the moisture content of the materials in the wall it is the RH which is decisive which means the moisture content in the materials varies less in 2015 than in 2011 even though the variation in absolute vapor content is the same. The smaller RH variations are beneficial for preventing moisture induced movements and cracks in the materials of the wall.

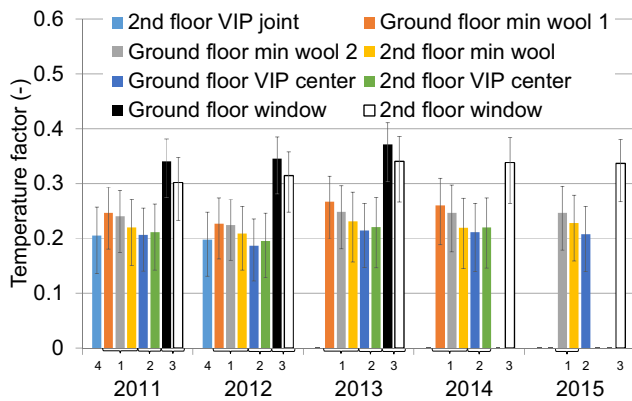
Fig. 6. The temperature factor calculated using Eq. (1) for the annual average temperatures for 2011, 2012, 2013, 2014 (and January till September 2015). The error bars show how the temperature factor could vary in the worst case with a sensor accuracy of $\pm 0.5^\circ\text{C}$. The braces show the same locations in the ground floor wall and 2nd floor wall as defined in Fig. 3 (left). From left: 2nd floor VIP–VIP joint, ground floor mineral wool 1, ground floor mineral wool 2, 2nd floor mineral wool, ground floor center-of-panel, 2nd floor center-of-panel, ground floor window and 2nd floor window.

The temperature factor is expected to be lowest at the center-of-panel. However, in 2011, the temperature factor is lowest at the VIP–VIP joint but in the following year it is lowest at the location at the center-of-panel in the 2nd floor wall. Unfortunately, these measurement locations are only possible to compare during 2011 and 2012. Based on these two years, the thermal bridge between the VIPs seems not to influence the thermal resistance of the wall as much as the thermal bridge at the mineral wool strips between the VIPs. The difference is not as large between this location and the center-of-panel for the 2nd floor wall as in the ground floor wall. The reason for this is not known. It could be that the overall thermal resistance of the 2nd floor wall is lower than for the ground floor wall which makes the differences between the temperature factors smaller.

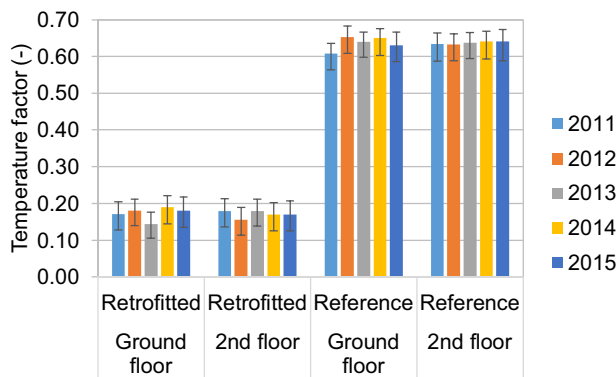
Fig. 7. The temperature factor calculated using Eq. (1) for January, 2011–2015 for the retrofitted walls (behind the center-of-panel, Fig. 3 left, loc. 2) and reference walls. The error bars show how the temperature factor could vary in the worst case with an accuracy of the sensor of $\pm 0.5^\circ\text{C}$.

Comparing the reference wall with the retrofitted wall gives an approximation of how much the thermal resistance of the wall has been improved. For this analysis the average temperature for January each year 2011–2015 was used to calculate the temperature factor. The temperature factor in the retrofitted walls (behind the center-of-panel, Fig. 3 left, loc. 2) and reference walls during January are presented in Fig. 7 together with the maximum deviation which could be caused by the sensor accuracy of $\pm 0.5^\circ\text{C}$.

It is clear that the thermal resistance of the wall has been substantially improved after the retrofitting. In the reference wall about 64% of the temperature drop was over the uninsulated brick and wooden parts. After the retrofitting only about 17% of the temperature drop was over that part of the wall. The tendency is most clear during winter time since the solar radiation during summer sometimes increased the temperature in the wall above the outdoor temperature, giving a negative value for the temperature factor. The same situation was reached when the outdoor temperature exceeded the indoor temperature. The stable temperature factors during the five years for both the reference and retrofitted walls showed that the thermal performance of the walls were roughly the same during this periods.
