# On the delamination phenomenon in the repair of timber beams with steel plates

Giovanni Metelli\*, Marco Preti, Ezio Giuriani

Department of Civil, Environmental, Architectural Engineering and of Mathematics, University of Brescia, Italy

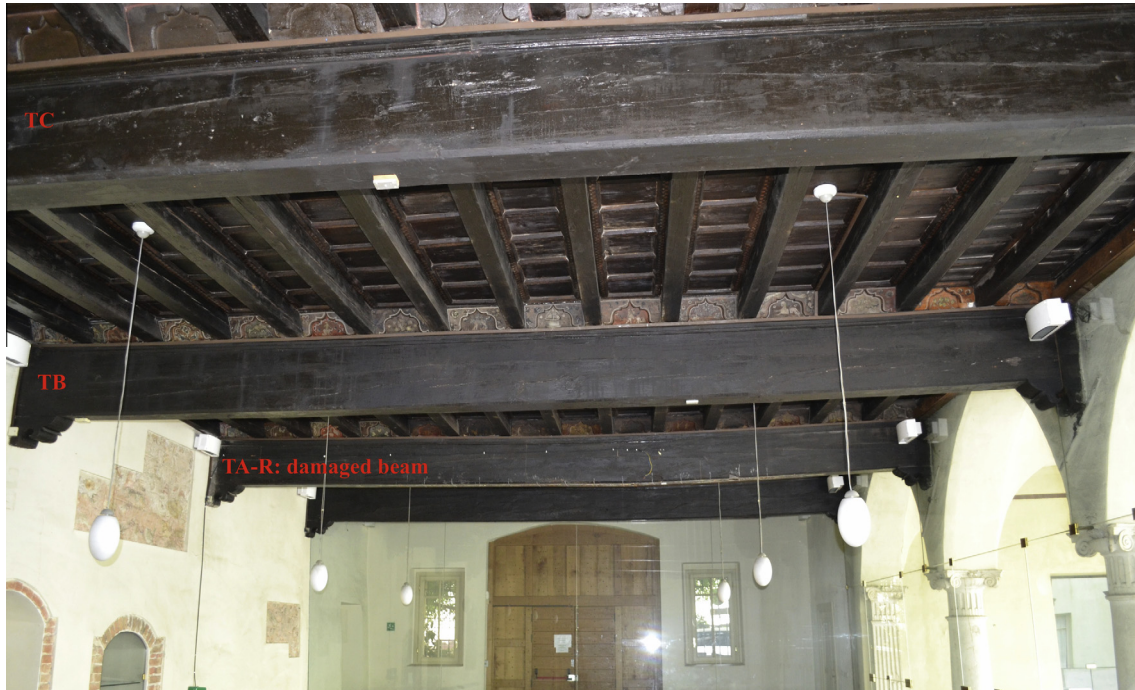
Fig. 3. Wooden floor of "Palazzo Calini ai Fiumi" before the repair (Brescia – Italy).

On 2000 it was observed that one of the main beams (labelled TA-R in Fig. 3) was characterised by a large deflection equal to 70 mm ( $\approx L/100$ ), caused by the formation of dangerous (60 mm deep) transversal cracks originating from a large knot located at the midspan soffit (Fig. 4). The deflection of the adjacent main beams was markedly lower at about  $L/180$ , thus showing overall good conservation of the ancient floor. A wide transversal crack (A in Fig. 4a and c) spread from a large wooden knot placed at the beam section soffit to the beam side joining a longitudinal crack on the beam side. A second severe crack (B in Fig. 4a and c) developed from the same knot with a depth of close to 60 mm and joined a second significant transversal crack (C in

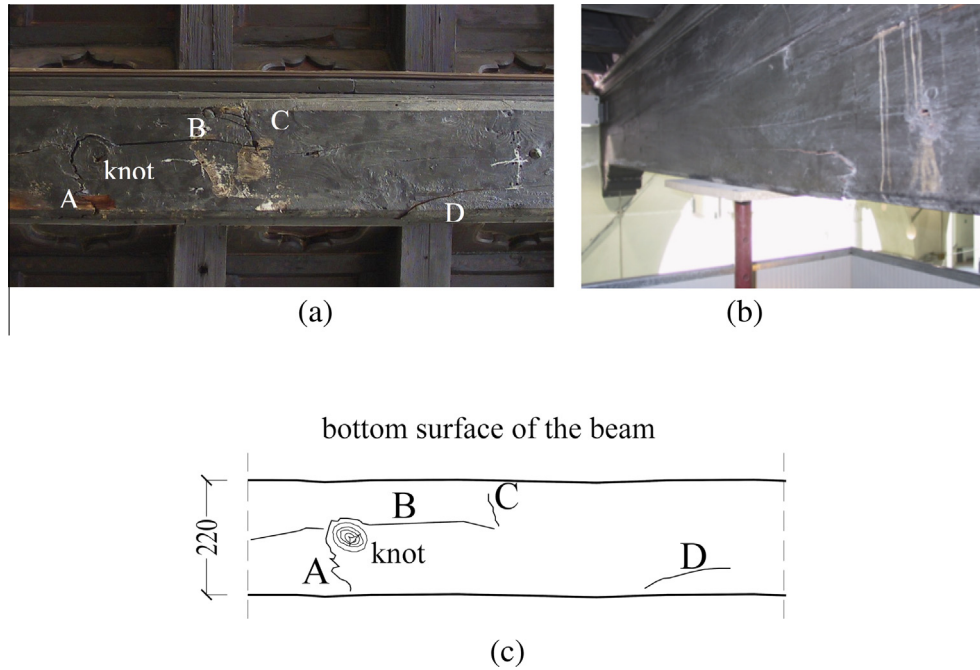
Fig. 4a and c). A third longitudinal crack (D in Fig. 4), originating from a second knot, characterised the southern side of the beam at a distance of about 2 m from the support. The crack pattern is also depicted in Fig. 4c.

Fig. 4. Details of splitting cracks at the beam soffit (a), on the beam's southern side (b) and crack pattern on the beam's bottom surface (c).

penetration tests on the beam of the Palazzo Calini showed its good conservation with an absence of wood decay, thus confirming the possibility of the beam repair limited to the splitting cracks at the beam midspan.

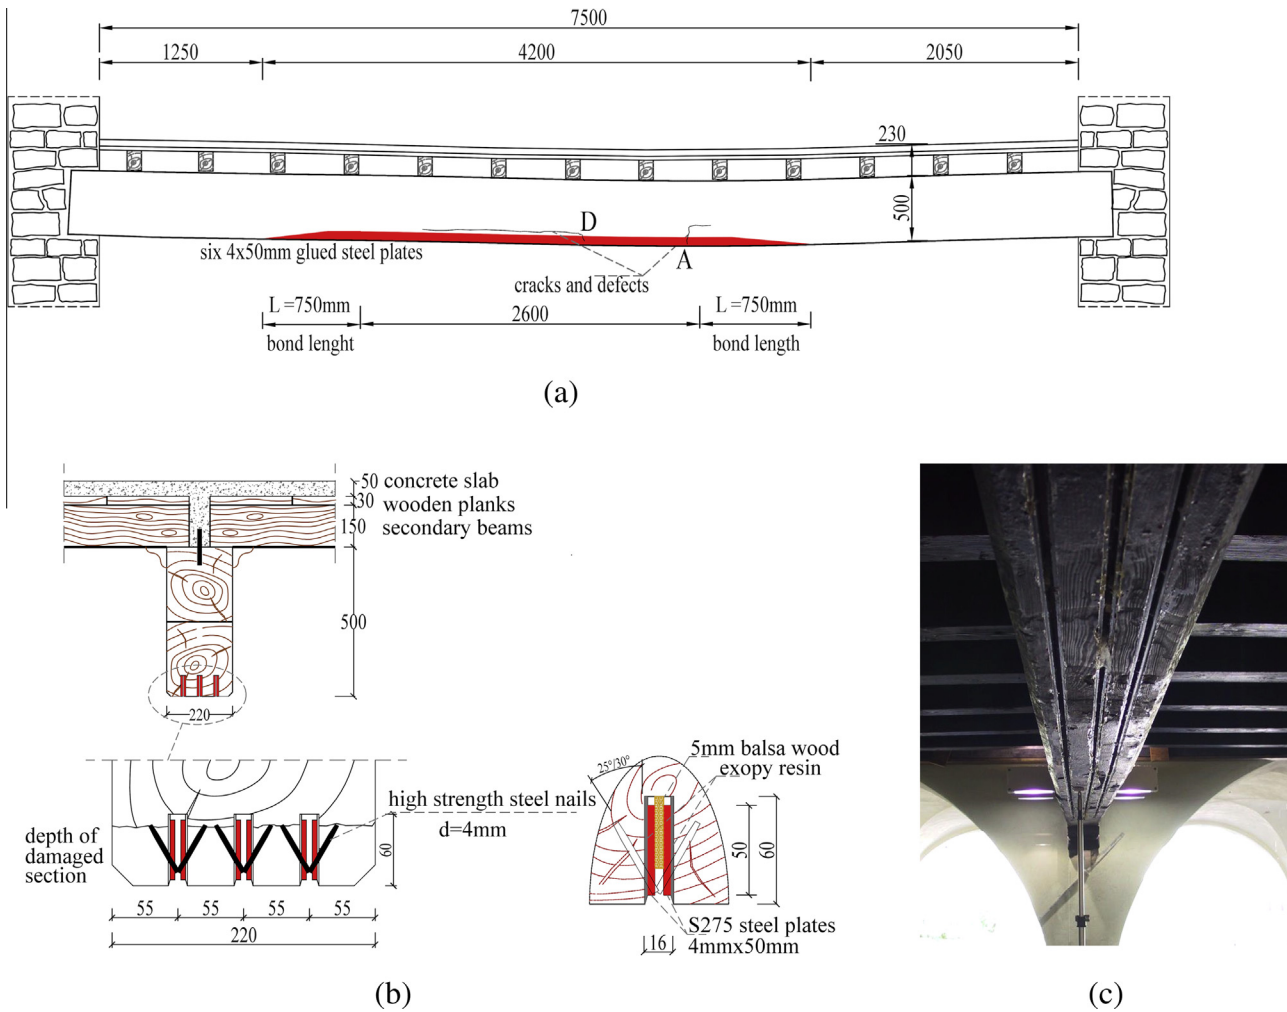
**Fig. 5.** Repaired beam of Palazzo Calini ai Fiumi (Brescia, Italy): beam deflection and crack pattern on the beam's south side (a); repaired cross section (b); soffit surface with the longitudinal glued steel plates (c).

The fifteenth-century timber beam was repaired on 2001 with steel plates glued to the timber with epoxy-resin adhesive (Fig. 5a). The grooves had a limited width of 16 mm and a depth that varied from 60 mm at the midspan to 0 mm at the groove ends in order to minimise wood removal. On each side of the groove a 4 mm thick steel plate was glued leaving a clearance of about 5 mm between the two steel plates (Fig. 5b). The mechanical properties of the epoxy-adhesive are listed in Table 1.

The six steel plates (4 mm thick, 50 mm deep and 4.2 m long – S275 grade steel having a nominal yield strength  $f_{yk} = 275$  MPa) were designed to guarantee an adequate strength and stiffness to the repaired beam. The design criteria for these reinforcements is based on the assumption that they carry the tensile action corresponding to the cracked portion of the timber section with a steel stress ( $\sigma_s$ ) of 100 MPa at service loading:

The bond length ( $l_b = 750 \text{ mm}$  in Fig. 5) of the steel plates was selected to ensure the design axial strength ( $F_{yd}$ ) of the reinforcements, given by Eq. (3), to be transferred to the undamaged zone of the timber beam. A uniform distribution of shear stresses was assumed along the bond length, as given by the following expression:

Furthermore, a set of high strength steel nails (diameter 4 mm, length 60 mm, with 50 mm pitch) was also placed along the 0.75 m bond length of the steel plates (Fig. 5b and c). This nailed connection guarantees the transmission of the load from the steel plates to the wooden beam in case of loss of adhesion due to fire or delamination due to stress concentration. The nails were forced into calibrated holes (3.5 mm in the timber beam and 3.7 mm in the steel plates) made using a specific template. They were drilled

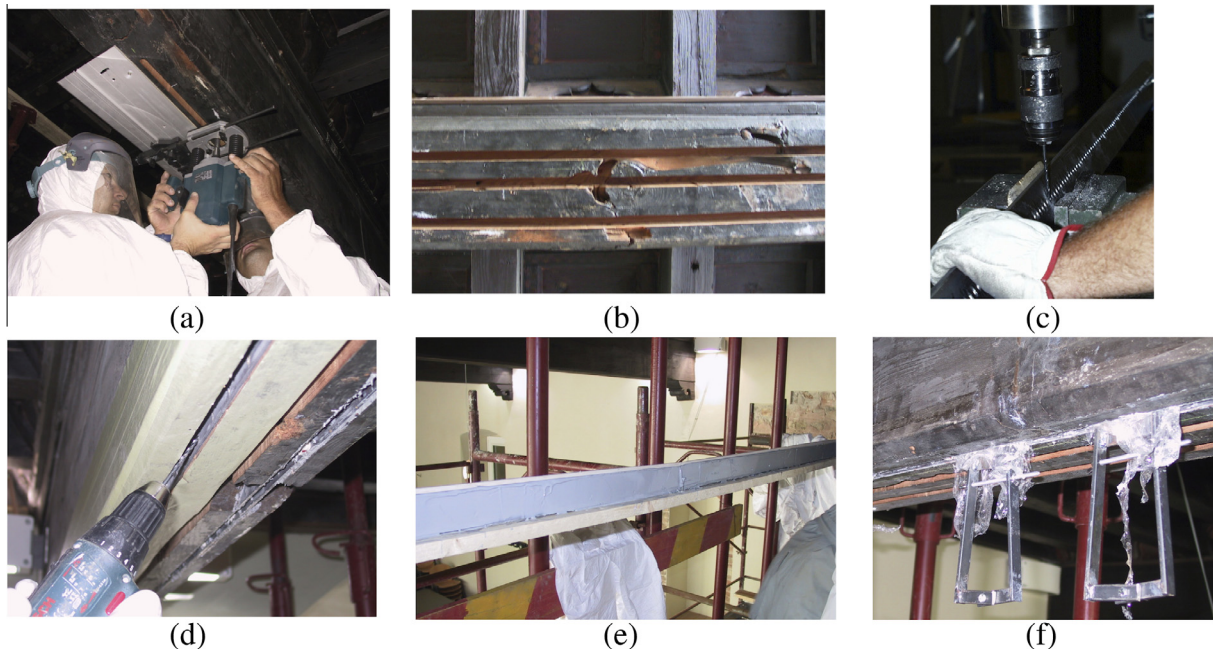
**Fig. 6.** Repair of the historical beam at Palazzo Calini ai Fiumi (Brescia, Italy): (a) beam notching with the end miller machine and the slide guide; (b) grooves before gluing of the reinforcements; (c) pre-drilling of the steel plates; (d) pre-drilling of the holes in the timber; (e) application of the adhesive on the steel plates; (f) wedges applied during adhesive curing.

With regard to the technological procedure of the proposed technique, Fig. 6 shows the main phases of the repair work. Firstly, tubular steel props were used to support the loads during beam repair (Fig. 4b). Many props were erected at the secondary beam ends and at the main beam soffit to unload the damaged beam from the floor's dead loads before applying the reinforcements. These props were tightened to recover a beam deflection equal to 3 mm. Then, the three grooves were routed along the bottom surface of the beam in its damaged region with an end miller and a slide guide (Fig. 6a and b). The plates were pre-drilled with a specific template at the laboratory of the University of Brescia, thus providing the correct inclination of the holes within the plate thickness (Fig. 6c). Then, the steel plates were placed in each groove to be used as template to pre-drill the holes in the timber for the nailed connections (Fig. 6d). The grooves were cleaned with a brush and vacuum while the steel plates were sandblasted to ensure a satisfactory bond between the wood substrate and the steel plates. Finally, the epoxy-resin was applied to the steel plates and the groove sides and the nails were inserted into the holes (Fig. 6e). It should be noted that the thixotropic properties of the epoxy-resin adhesive allowed the plates to be glued to the groove surfaces without requiring moulding or formwork. Several wedges were applied between each pair of bonded plates to guarantee the positioning of the plates and to provide pressure during the adhesion curing (Fig. 6f). Ten days after the repair, the props were removed from the floor and the repaired beam showed an instantaneous deflection of about 1.5 mm.

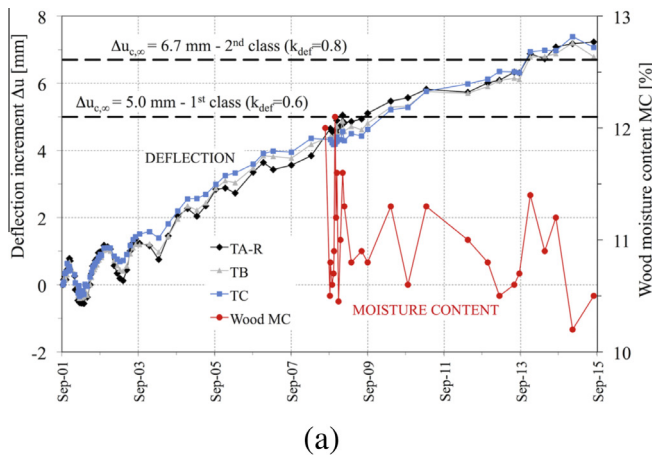
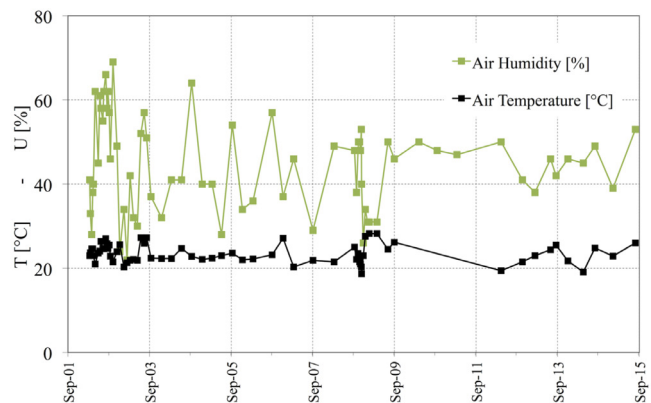
More than fourteen years after the repair, the deflection of the repaired beam TA-R has increased by 7.23 mm. The deflection of the undamaged TB and TC beams has increased by 6.79 and 7.07 mm, respectively (Fig. 13a). It is worth noting all the three monitored beams have shown the same deflection increase, which confirms the effectiveness of the adopted technique to repair the damaged beam.

From September 2001 to November 2008 the deflection of the all the floor beams was characterised by a mean increase of about 0.7 mm/year. During the same period, the room humidity varied between 22% and 68% while the room temperature varied from 18 to 28 °C (Fig. 13b). In Fig. 13a the plotted data show the cyclic variations of the beam deflection, with maximum amplitude of about 1.4 mm during the first year after the intervention, due to the seasonal cyclic variations of temperature and moisture content. The deflection increase of the floor of Palazzo Calini was likely influenced also by the mechano-sorptive creep behaviour of wood.

Fig. 13. Monitoring of the floor in Palazzo Calini (Brescia, Italy): deflection (from 2001 to 2015) and wood moisture content (from 2008) (a); room humidity and temperature (b).

This may be confirmed in Fig. 13b, which shows the several cyclic variations of room humidity recorded from September 2001 to November 2008. For this reason, on November 2008 an air humidifier was installed in the room in order to reduce the peak of air humidity variation. As a result, the wood moisture content was stabilised around a value of 11% and the beams' deflection increase was reduced to 0.35 mm/year over the last seven years.
