# Seismic retrofitting of full-scale RC interior beam-column-slab subassemblies with CFRP wraps

Cailong Ma, Daiyu Wang, Zhenyu Wang\*

Key Lab of Structures Dynamic Behavior and Control of the Ministry of Education, Harbin Institute of Technology, Harbin 150090, China  
School of Civil Engineering, Harbin Institute of Technology, Harbin 150090, China

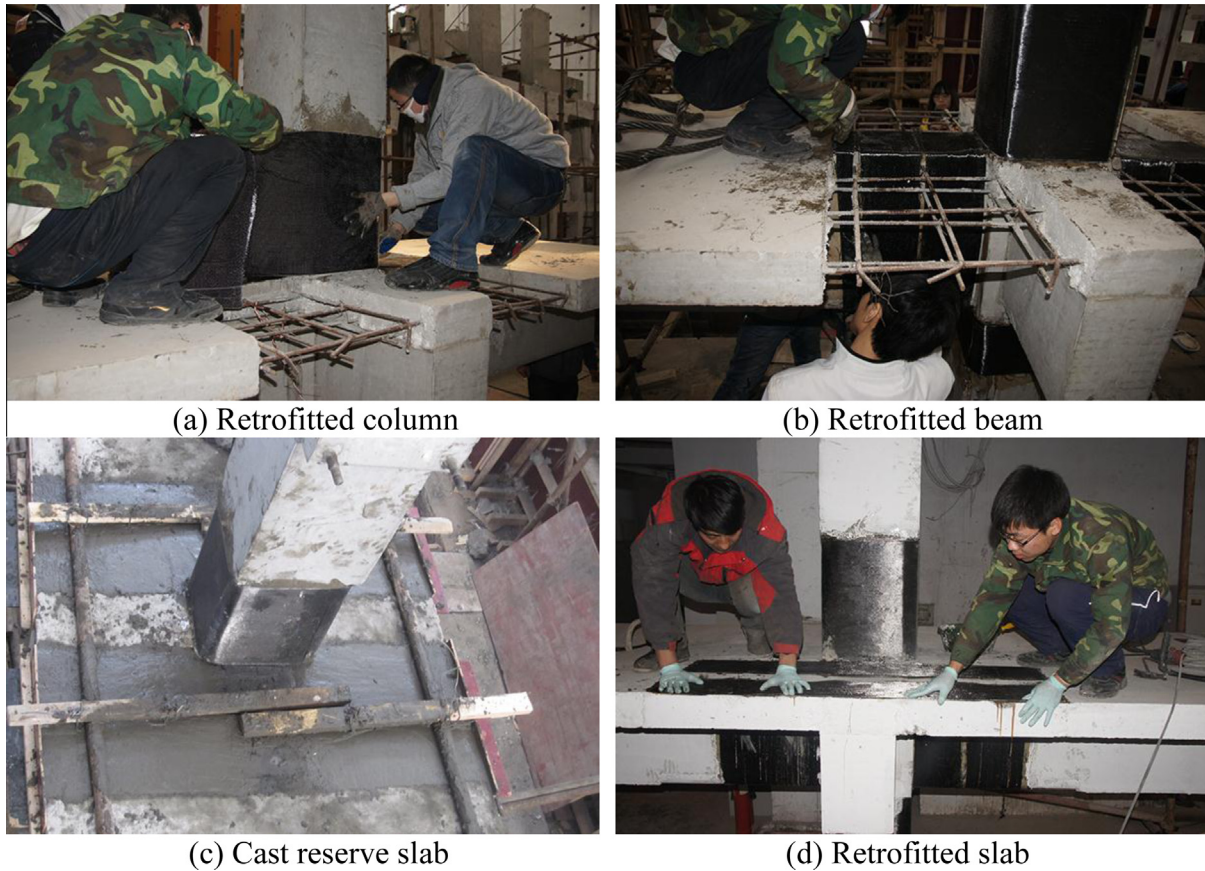
Fig. 3. Pictures showing retrofitted process of specimen SCBW.

Fig. 2 shows the retrofitting schemes of all specimens. The first retrofitted specimen, namely SC, was retrofitted by laterally wrapping 3 layers of CFRP only at the potential plastic hinge regions of upper and lower columns with a height of 500 mm and 250 mm, respectively. The second retrofitted specimen, namely SCBU, was retrofitted in the following way: (1) four one-layer L-shaped CFRP strips [sheets 1 and 2 in Fig. 2] with 250 mm width were bonded at plastic hinge regions of columns and beams along the direction of longitudinal reinforcement, which could improve the flexural strength of beam and column; (2) three layers of CFRP sheets with a height of 250 mm and 500 mm [sheets 3 and 4] were wrapped laterally at the potential plastic hinge regions of upper and lower columns; (3) one-layer U-shaped CFRP strips [sheets 5] were applied to each beam end to prevent premature debonding of the L-shaped longitudinal CFRP sheets and to enhance the shear capacity; the lateral CFRP strips [sheets 6] were used to prevent the U-shaped CFRP strips debonding; (4) the U-shaped CFRP strips [sheets 7] were used at the end of transverse beams; four one-layer CFRP strips with 200 mm width [sheets 8] were attached on the surface of slab covered 1400 mm in the longitudinal direction; these straight strips were fixed by six 100 mm width strips [sheets 9] at an interval of 100 mm. The detailed retrofitting scheme of specimen SCBU is shown in Fig. 2(e). For the third retrofitted specimens, namely SCBW, all the retrofitting processes were the same as the specimen SCBU, except the U-shaped strips at the longitudinal beams were replaced by one-layer laterally wrapped CFRP [sheets 10]. To achieve this goal, the slab of the retrofitted area was not cast until the longitudinal beams were wrapped by CFRP sheets. After the beams were retrofitted, the missed slab was cast and cured and then retrofitted with the same scheme as specimen SCBU. The retrofitting process of specimen SCBW are shown in Fig. 3.

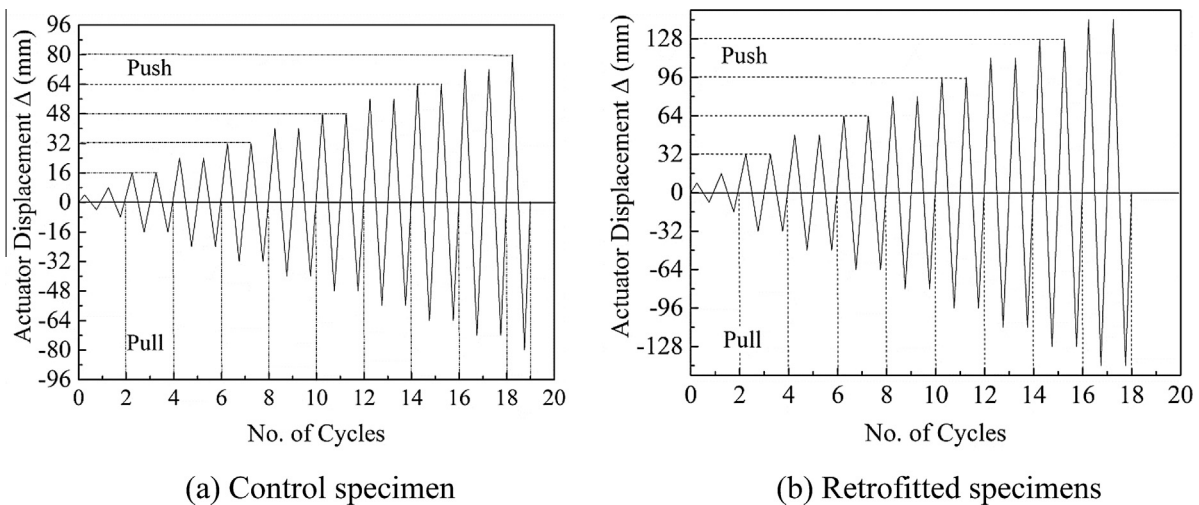
Fig. 6. Cyclic loading schemes.

increment of  $\Delta_y$ . For retrofitted specimens, the first two once reversed cycles were applied with the increment of  $\Delta_y$ , while the each following displacement level was reversed twice with the increment of  $2\Delta_y$ . The tests were finally halted if the lateral load dropped to approximately 80% of the peak load.

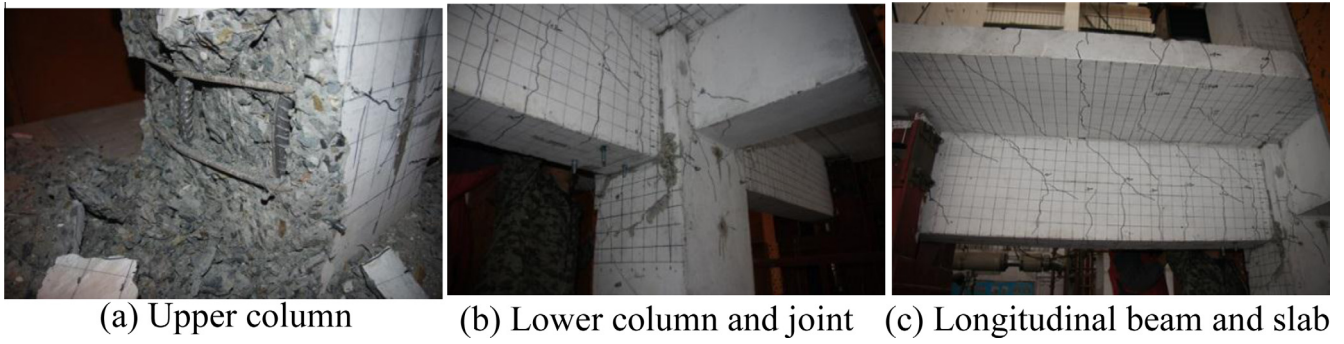
Fig. 7. Failure modes of specimen C.

The failure modes of the control specimen C are shown in Fig. 7 and a brief summary of the test observations were illustrated as follows. With applying the lateral load, the flexural cracks initially occurred at the plastic hinge regions of longitudinal beams. Then the existing flexural cracks kept developing with increasing width and length and new diagonal shear cracks appeared at the beam ends. In addition, horizontal flexural cracks occurred at plastic hinge regions of upper column end and the surface of the slab. The relative wide splitting at beam-column interfaces was observed at the drift ratio of 1.75%. Bottom longitudinal steel bars of the longitudinal beams were also found to be yielded and slipped at this displacement level. As the lateral drift ratio increased to 2.0%, spalling of concrete cover at the plastic hinge region of the upper column was noticed. The concrete spalling area extended with the increase of lateral displacement. Finally, the

plastic hinge was formed at the upper column end. The cover concrete was severely spalled and crushed leading to the exposure of internal hoops and longitudinal steel reinforcements. It was found that the internal hoops have been bent out and the longitudinal bars have been buckled.

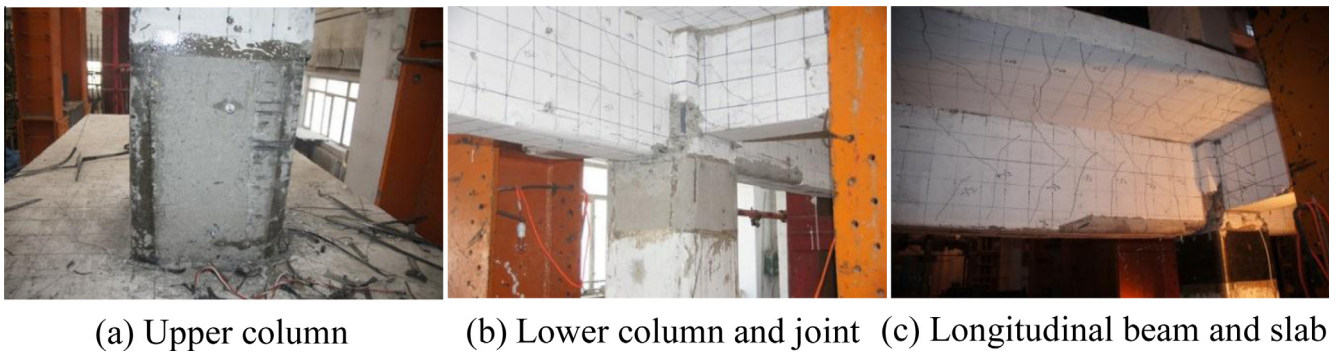
Fig. 8. Failure modes of specimen SC.

After being retrofitted with CFRP, the failure modes of retrofitted specimens were changed from the unexpected column-hinge mechanism to the expected beam-hinge mechanism. Flexural cracks firstly appeared at the longitudinal beams. The beam-column interface splitting and bottom longitudinal bars yielding and slipping were also observed. With drift ratios increasing, the longitudinal beams were seriously damaged and cover concrete at the corner of joint region partly spalled off. Finally, the ends of longitudinal beams severely damaged and the plastic hinge was developed. Following removal of the CFRP wraps around column ends after the tests, it was evident that the retrofitted part of the column basically remained intact. For specimen SC, the damage was concentrated on the uncovered longitudinal beam ends and joint core region in the form of concrete cover cracking and spalling, especially at the corner areas, as shown in Fig. 8(b) and (c). For specimens SCBU and SCBW, severe concrete spalling occurred at the corners of uncovered joint core region leading to the total exposure of corner longitudinal steel reinforcements of columns, as shown in Figs. 9(b) and 10(b). Serious debonding of the CFRP sheets on the slab was also observed. The bond between CFRP and concrete of slab was almost destroyed at the end of the tests. Specimens SC and SCBU exhibited similar beam-hinge mechanism failure modes. Specimen SCBW failed due to the severe damage of beam end near the support and the beam-column interface.

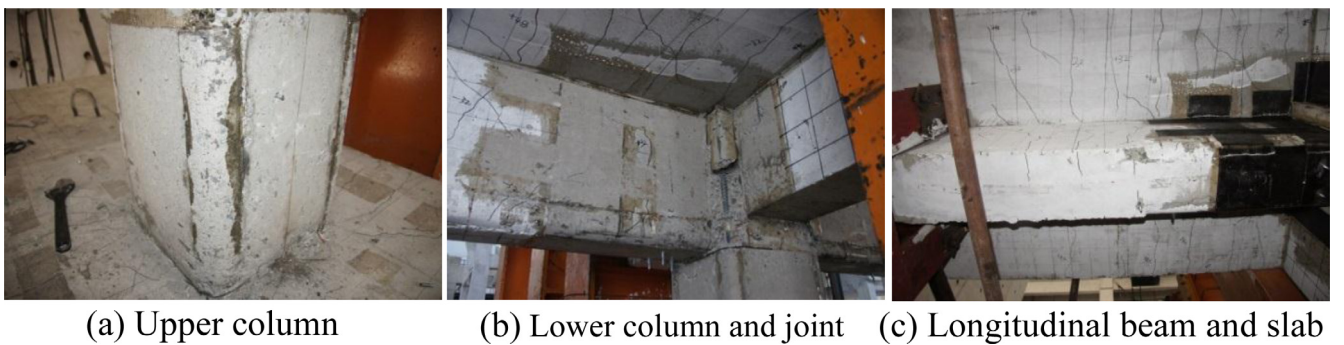
Fig. 9. Failure modes of specimen SCBU.

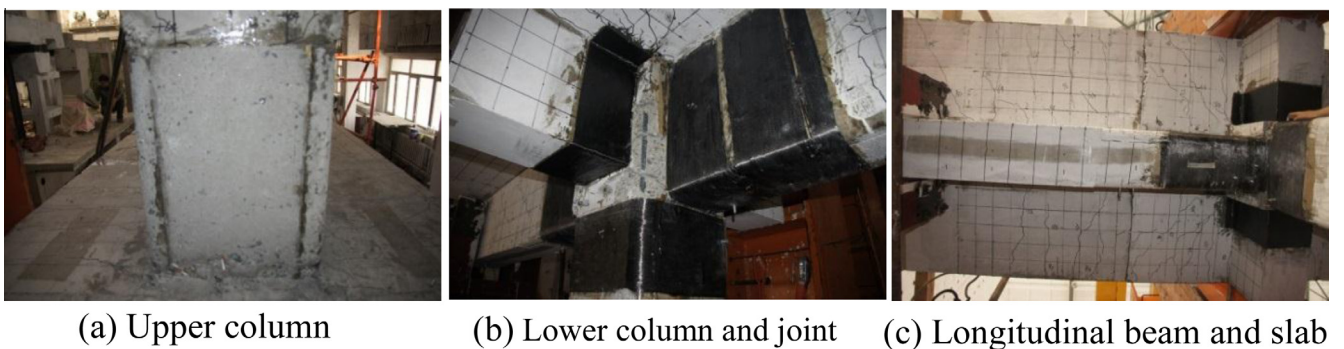
Fig. 10. Failure modes of specimen SCBW.

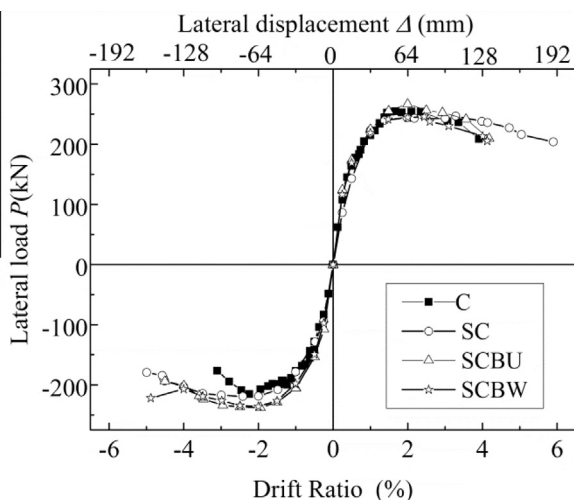
Fig. 12. Load-displacement envelope curves.

Fig. 12 shows the load-displacement envelope curves of the tested specimens, which were obtained from load-displacement hysteretic curves. The main seismic performance indexes of all specimens are summarized in Table 2, and the values of all parameters are the average value in push and pull direction due to the asymmetry of test envelope curves. The yield point is defined by using the energy equivalent method [38]. The ultimate displacement ( $\Delta_u$ ) and corresponding drift ratio ( $\delta_u$ ) were obtained from the point where the lateral load reduced to 85% of the peak load ( $P_c$ ). The ductility ratio ( $\mu$ ) is equal to the ratio of ultimate displacement ( $\Delta_u$ ) to the yield displacement ( $\Delta_y$ ).

As illustrated in Table 2, the CFRP retrofitting schemes have little influence on the yield displacement ( $\Delta_y$ ) and the yield load ( $P_y$ ). The peak displacements ( $\Delta_c$ ) of retrofitted specimens were larger than that of specimen C, and the peak drift ratios were about 2% for all the specimens. However, compared with the control specimen C, the ultimate displacements ( $\Delta_u$ ) of specimen SC, SCBU, and SCBW increased by 49%, 16%, and 19.8%, respectively, and the ultimate drift ratios met the requirement of the ultimate inter-story drift ratio (i.e. 2%) of RC frame structures specified by the national seismic design code of China (i.e. GB50011-2010). The ductility ratio ( $\mu$ ) of specimen SC, SCBU, and SCBW were

increased by 41%, 20% and 27% compared with that of control specimen, respectively. The plastic deformation capacity of the specimens was significantly improved after being retrofitted by CFRP, especially for specimen SC. It is evident that retrofitting of the plastic hinge regions of columns is the most effective technical in improving the seismic performance of interior RC beam-column-slab subassemblies among the three retrofitting schemes.

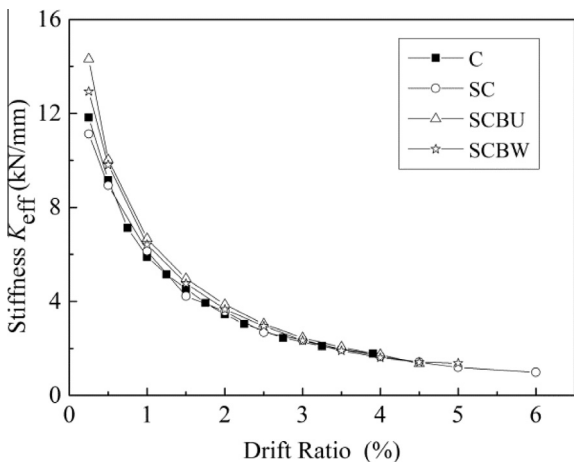
Fig. 13. Stiffness degradation of tested specimens.

The stiffness degradation is usually attributed to concrete non-linear deformations, concrete cracking, yielding of longitudinal bars, steel reinforcement bonding-slippage. The degradation of effective stiffness ( $K_{eff}$ ), which is defined as the secant stiffness at the unloading point of each displacement level, is shown in Fig. 13. It is indicated that specimen SCBW and SCBU exhibited larger effective stiffness than that of specimen C and SC in the initial stage of lateral loading. Moreover, the control specimen C and retrofitted specimen SC had approximately the same effective stiffness and its degradation. The main reason is that the CFRP sheets [sheets 5 and 6] effectively delayed the flexural cracks of longitudinal beams for specimen SCBU and specimen SCBW, and then delayed the stiffness degradation. As the drift ratio increased larger than 2.5%, the effective stiffness degradation behavior was approximately the same for all the specimens. This is due to the longitudinal reinforcements had slipped before the drift ratio of 2.5% and no new cracks generated after the drift ratio of 2.5%. In general, the results indicate that the FRP retrofitting has little influence on the effective stiffness of specimens.

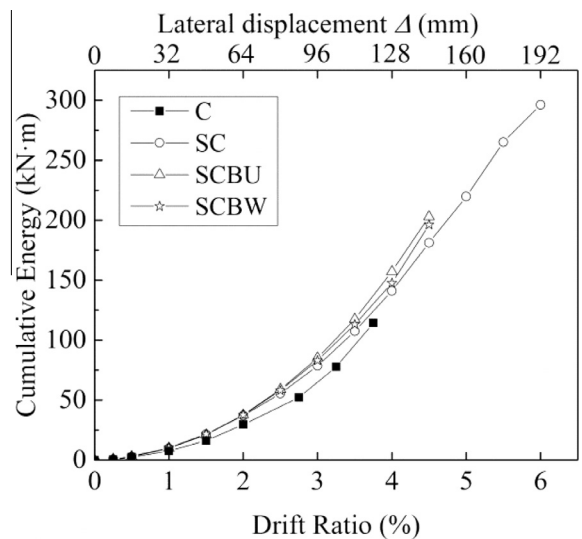
Fig. 14. Cumulative energy dissipation.

enclosed area within load-displacement loop of the first cycle at each drift ratio. Fig. 14 shows the cumulative energy dissipation versus drift ratio curves for all tested specimens. After the drift ratio increased up to 1%, the single-loop energy dissipation of retrofitted specimens was apparently larger than that of the control specimen C. The cumulative energy dissipation of retrofitted specimens was greatly larger than that of the control specimen C. The single-loop energy dissipation of specimens SCBU and SCBW was larger than that of specimen SC at a certain drift ratio over 3%, but the cumulative energy dissipation was less than that of specimen SC. This indicates that the energy dissipation capacities of retrofitted specimens were improved and specimen SC has the largest energy dissipation capacity among all the retrofitted specimens.

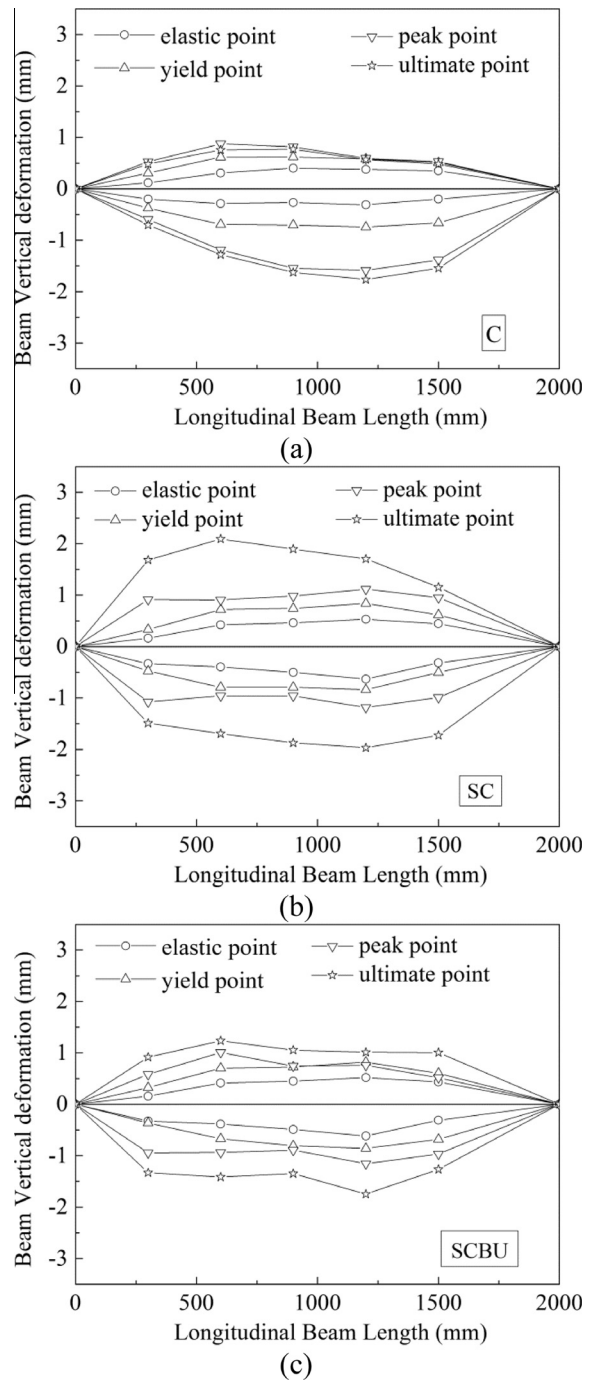
Fig. 18. Beam vertical deformations.

The vertical deformations of longitudinal beams were mainly the flexural deformations. Fig. 18 shows the vertical deformation responses of longitudinal beams of specimen C, SC, and SCBU at elastic, yield, peak and ultimate point. For the specimen C, the

beam vertical deformations at peak point were approximately equal to that at ultimate point and the deformation in negative direction was larger than that in positive direction. The main reasons for this were: 1) the failure of the control specimen concentrated on the upper column end after the drift ratio of 2.0% and the beam end hinge failed to form; 2) the existence of slab increased the negative bending stiffness of longitudinal beam; 3) the existence of transverse beams as the supports of slabs effectively restricted the deformation of slabs, then the composite effect of transverse beams and slabs further increased the bending stiffness of longitudinal beams.

For retrofitted specimens, the beam vertical deformations at the ultimate point were larger than that at the peak point, especially for specimen SC. In addition, the deformations in negative and positive direction were approximately the same at the same drift ratio level. The comparison of vertical deformation of longitudinal beams between control and retrofitted specimens indicated that the deformation of retrofitted specimens was larger than that of control specimen. This attributed to the damage of retrofitted specimens mainly concentrated on the plastic hinge regions of longitudinal beams and slabs, which reduced the flexural stiffness of the beams and further increased the deformation. It is also found that the beam vertical deformation of retrofitted specimen SCBU was smaller than that of the retrofitted specimen SC due to the retrofitting of the longitudinal beams and slab, especially the L-shaped CFRP strips [sheets 1 and 2] at plastic hinge regions of columns and beams along the longitudinal direction.
