# Shear strengthening of unreinforced masonry wall with different fiber reinforced mortar jacketing

Yavuz Yardim<sup>a,b,\*</sup>, Ornela Lalaj<sup>c</sup>

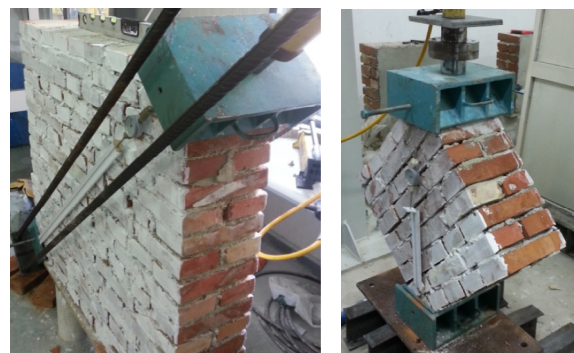
Fig. 1. Test setup for diagonal shear test.

(a) standard size specimen setup

(b) half-scale specimen setup

The test setup consisted of the loading frame, two steel loading shoes, a hydraulic jack and two dial gauges for the small and half-scale walls. Since the standard size walls were too big to be moved with ease, a modification was done to the test setup. Instead of the loading frame, the two loading shoes were fixed by means of 4 steel rods, riveted on both ends (Fig. 1a). The load was applied by means of the hydraulic jack at small increments to allow for the detection of cracks prior to failure. Fig. 1 shows the ASTM test setup, and the adopted setups for the standard size and half-scale specimens (Fig. 1b).

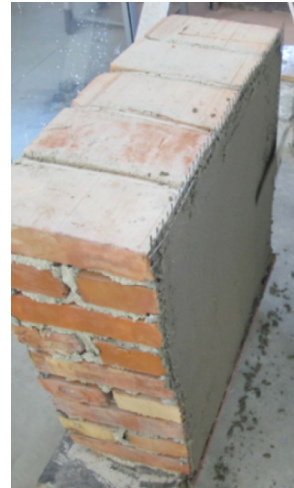
(a) Application of TRM strengthening to masonry walls

The fibers that were used for strengthening the URM walls in this study are glass fibers SikaWrap 350G Grid [18], pre-embedded in epoxy. This material has been specifically designed for strengthening of masonry walls. The fiber was fixed to the wall by means of a special type of mortar SikaMonoTop 722 [7], SIKA. The TRM nets were cut to fit the size of the walls. The mortar was prepared by mixing the Mono Top mortar with water at 20–21% in mass of the mortar mixture. Since the pot life of this special mortar is 30–45 min, small portions of mix were prepared at a time. Then, a thin first layer of mortar was applied on the surface of the walls. The net was placed and embedded on the first layer, and covered with a second layer of mortar, which also fixed the net on the wall face (Fig. 2a). The walls were left to cure in environment conditions for 28 days. This strengthening was used for one and two sides of the masonry wallet specimens.

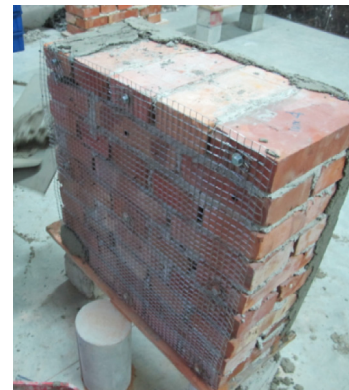
(b) Application of Ferrocement strengthening of masonry walls

The ferrocement jacket consists of a galvanized steel mesh that was attached to the wall and worked as an external reinforcement to the wall. The mesh was fixed to the wall by means of mechanical anchors and common mortar. The steel wire mesh was cut equal to the walls' dimensions, 650 × 650 mm. Two layers of wire mesh were used for each side of the wall. Surface preparation was required in order to install the steel wire meshes. Anchors are needed to be placed at certain distances, at least every 30 cm [19]. For more versatility of work and application, threaded bolts of diameter 8 mm and length 70 mm were used as anchors. Holes were preliminary drilled every 30 cm on both sides of the wall. Then, the wire meshes were placed on the faces and the anchors were fixed with care, in order not to break the bricks due to the extra stresses that come when threading. Afterwards, the walls were plastered on both sides with approximately 2–2.5 cm mortar (Fig. 2b). The ratio cement/sand used is 1:4, and the water content is 0.4 (W/C).

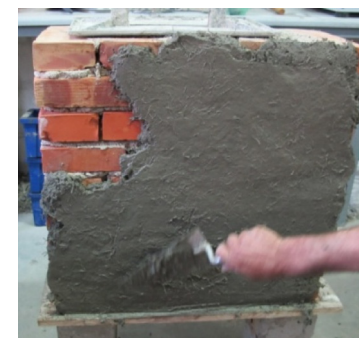
(c) Application of PP-FRM strengthening of masonry walls

**Fig. 2.** Application of strengthening to masonry walls (a) TRM; (b) ferrocement; (c) PP-FRM.

The last strengthening method is using polypropylene fiber mixed with plastering mortar. The walls were jacketed on both sides with 2–2.5 cm thick plaster that contains certain amounts of polypropylene fibers. The suggested percentage that does not affect the workability and does enhance the properties of the FRM is 1–2%, commonly used the value of 1.5% [15,20]. A commonly used mortar mix design for practical applications of FRM (mainly tunneling) consists of 1 portion cement and 4 portions of aggregate (both fine and coarse). This ratio yields FRM with very low workability. Therefore, the mortar produced for better workability with 1 portion sand, 1 portion cement, 0.5 (W/C) and 1.5% of fibers by volume. The fibers were dry mixed with the sand and the cement, and water was added in the end. The FRM was applied on both sides of the wall (Fig. 2c).

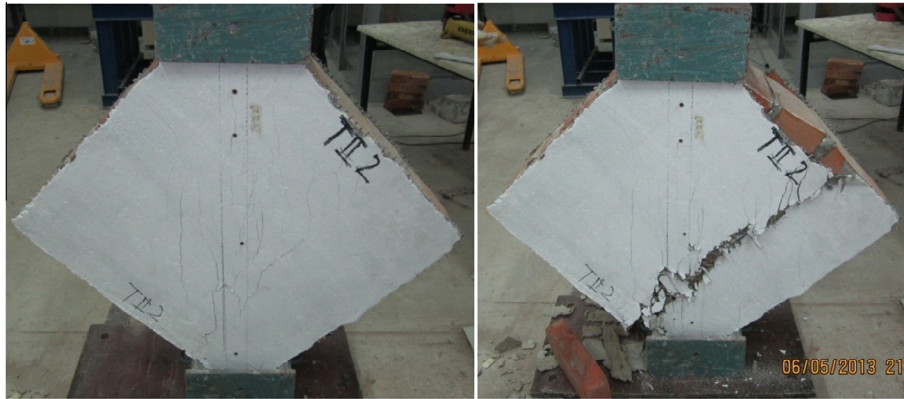
Fig. 5. TRM (TII) jacketed walls on both sides: (a) crack initiation along the compressed diagonal; (b) excessive cracking occurs and de-bonding.

jacket, the load is carried out by the wall, and cracks appear along the mortar joints. First TRM (TII) reinforced walls were tested under diagonal compression load. First cracks develop along the compressed diagonal of plastered surface of the specimen (Fig. 5). As the load increased, the cracks widened. The glass fiber net has yielded but it still holds the jacket together. Afterwards, the TRM-jacket was disconnected from the wall, which led to the transfer of the entire load to the wall itself. The increase in diagonal load carrying capacity of the TII two-sided strengthened wall is almost three times of the half size plain specimen. The glass fibers improve the deformation capacity as well. The behavior of both specimens is similar and they are characterized by similar stiffness and ultimate strengths. The failure of the specimens were took place after an excessive cracking and de-bonding of the reinforced plaster (Fig. 5b).

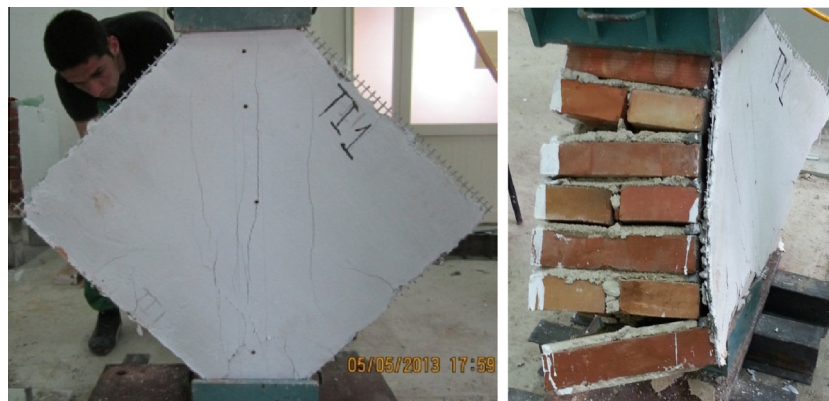
Fig. 6. TRM jacketed walls on one side only (TI): (a) crack development on the strengthened side, (b) inward bending of the strengthened side while cracks are still minor.

The strengthening configuration of TI yielded the lowest results in diagonal load carrying and deformation capacity. As the wall was strengthened in only one side, the section was not symmetric anymore. There was an increase in stiffness in one side of the wall, while the other side behaved as a plain wall. The plain side started to deform and crack at low levels of load, while the strengthened side didn't show any cracking. Afterwards, the cracks appeared in the TRM side as well (Fig. 6a). The ultimate load is almost 1.6 times the failure load of the plain walls. The plain side had a failure similar to that of plain wall, in a stepped fashion cracks. At the same time, the wall bent out-of-plane due to the difference in stiffness between the two sides (Fig. 6b).

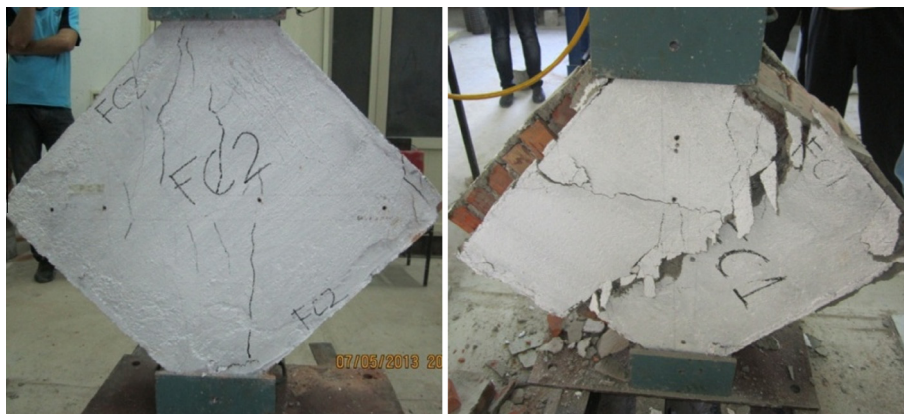
Fig. 7. Ferrocement jacketed wall: (a) hair-like cracks developing along the compressed diagonal; (b) yield of the jacket and total failure of second specimen.

The ferrocement jacketed walls (FC) were carried highest ultimate diagonal load compared to others. Hair-like cracks start to develop along the compressed diagonal. At a load of 110–115 kN several cracks have formed along the diagonal strip and start to widen (Fig. 7a). There are no splits in the bed/head joints and the specimens were failed at ductile manner. At the ultimate load plaster starts disconnecting from the wall (Fig. 7b). The ductile behavior of the specimens wall were not only depended on the addition of the wire mesh, which works as act external reinforcement, thus providing the ductility and energy absorption plain masonry walls lack, but also the connection of the jacket to the wall. Even after the yield of the steel, the mesh still could carry load. Both the load capacity and the deformation capacity of the ferrocement jacketed wall increased considerably compared to plain specimens.

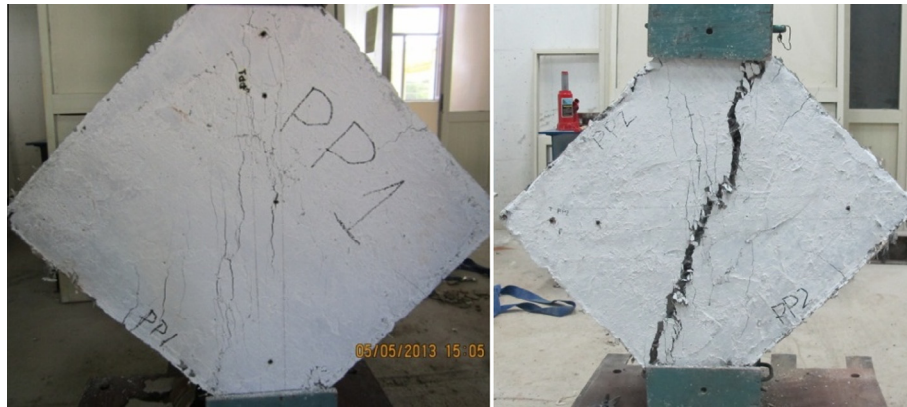
Fig. 8. Polypropylene jacketed walls: (a) cracks developing; (b) major crack and failure of second specimen.

The polypropylene jacketed specimen (PP) shows similar behavior with FC specimen, at the diagonal load of 70–90 kN, the first cracks occurring along the compressed diagonal (Fig. 8a). As cracks continued to propagate, the jacket began to disconnect from

the wall at the ultimate load (Fig. 8b). The failure of the wall began in the third course of bricks, by splitting the bed/head joints. After that the jacket was disconnected from the wall, and the wall itself disintegrated. The shear strength of the PP was increased 400% compared to PS specimen capacity.
