Construction and Building Materials

Review

In situ assessment of structural timber using the resistance drilling method – Evaluation of usefulness

Tomasz P. Nowak*, Jerzy Jasieńko, Katarzyna Hamrol-Bielecka

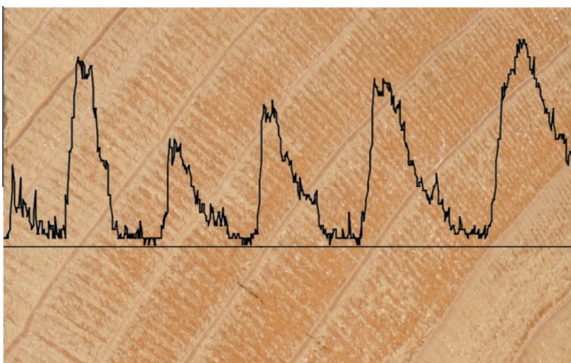
Fig. 2. Distribution of annual wood growth rings. Differences in density of earlywood and latewood are clearly visible.

Application of drilling resistance methods as field tests enables: localising internal damage and discontinuities in timber elements without affecting their functional properties [18]. It is possible to assess the extent of damage in the tested timber elements, inspect the state of timber covered by other materials (plaster, gypsum shells, walls, board covers etc.) without disassembly. Measurements need to be carried out in locations especially susceptible to weakening and biodegradation, such as for example: areas where wood connects with other materials (concrete, bricks), where wood contacts soil, in elements which are visibly damp or degraded or adjacent to door and window openings, as well as timber roof structures and attic spaces [19]. The drilling resistance method is also effective where assessment of timber condition in carpenter's joints is needed [20] and in the case of glued laminated timber. It is necessary, however, to note the differences the drilling resistance graphs register for specific lamellas [13]. It can be very difficult to interpret the differences, due to the density differences between them. Measurements of drilling resistance provide also for generating a graphical presentation of the distribution of annual growth rings [21,22] (Fig. 2).

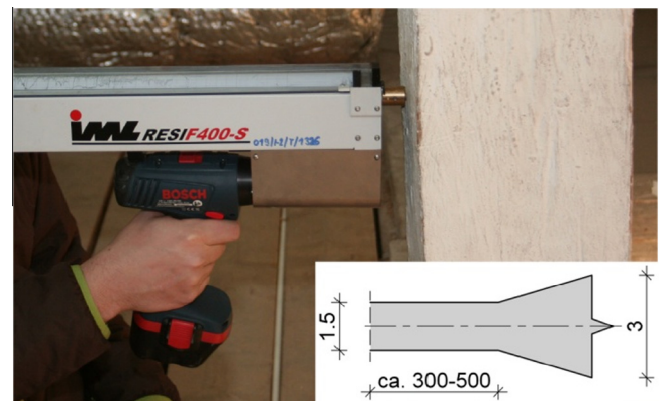
Fig. 3. Resistance drilling device during timber column testing. Drill shape and dimensions (mm) are shown in lower right corner.

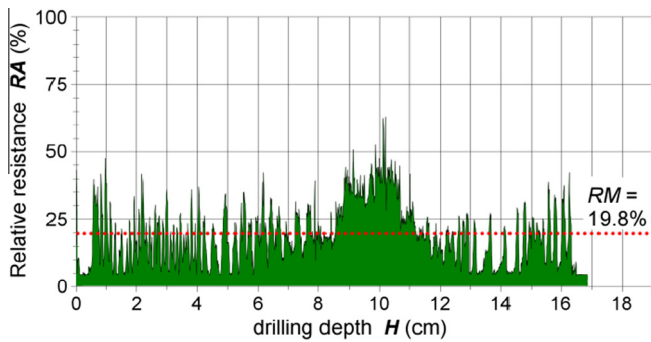
Fig. 4. Example of a drilling resistance graph with marked *RM* value.

Drilling resistance methods were used to test in-situ the condition of structural timber elements. Testing of drilling resistance of timber elements in floors, roofs and walls were carried out using an IML RESI F-400S drilling device with a drill bit of approx. 380 mm (Fig. 3). The resistance drilling device enabled measurements to be recorded at every 0.1 mm. To calculate the Resistance Measure (*RM*) value – Eq. (1), it was assumed that the entry and exit zone was 3 mm deep, which had not been taken into account in calculations. An example graph showing *RM* values is presented in Fig. 4.

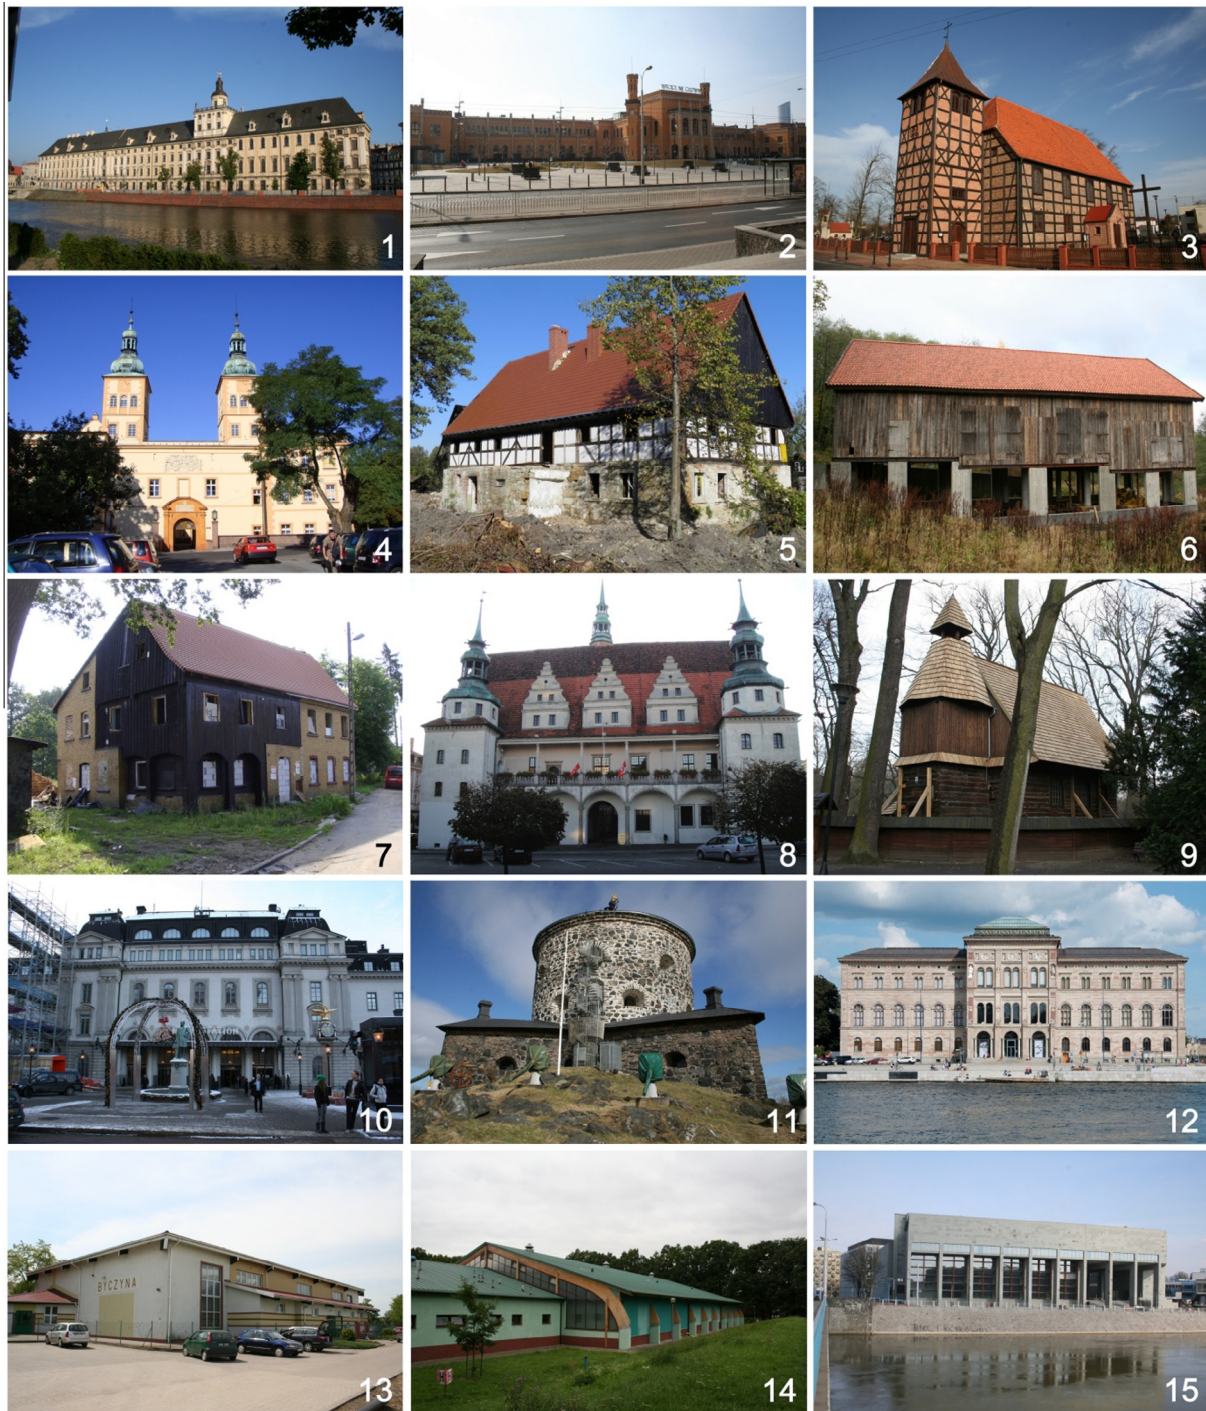
Fig. 5. Buildings for which drilling resistance tests have been carried out (numbered in accordance with descriptions in the text and in Table 3).

Testing of solid timber was carried out both in heritage buildings of very high historical value and in new buildings with structural elements made from glued laminated timber. A short description of the buildings, in which testing was carried out is presented below (see Fig. 5).

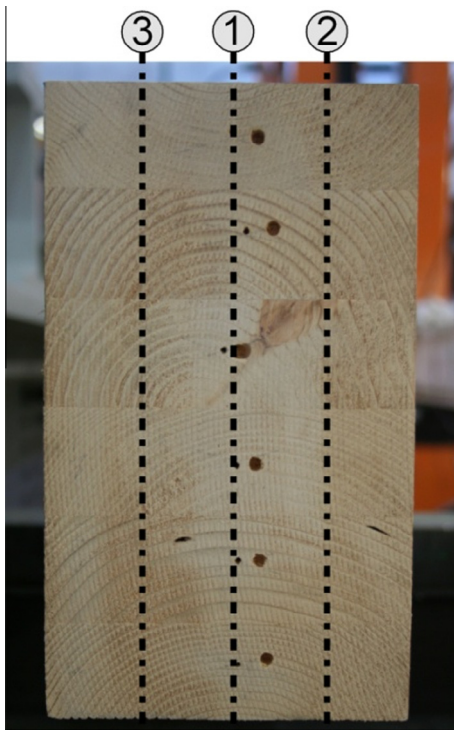
Fig. 8. Cross-section of the tested beam made from glued laminated timber with axes marking out the points where drilling resistance measures were taken (the openings visible result from tests carried out with stress wave and ultrasonic techniques).

For measure No. 2, the graph clearly indicates (Fig. 7), the influence on drilling resistance of the knot located in the third from the top lamination (Fig. 8). The knot has a higher density, but this higher density corresponds to a lower mechanical performance of the member. The drilling can be carried out randomly radially or tangentially to the growth rings. The tangential drilling is generally very uniform, because the differences between early and latewood are attenuated for a simple geometrical reason. In the case of glulam, however, interpretation of resistographic drilling results can be very difficult.
