Seismic retrofitting of the historical masonry structures using numerical approach

Cemil Akcay^a, Tarik Serhat Bozkurt^b, Baris Sayin^{a,*}, Baris Yildizlar^a

^a Istanbul University, Department of Civil Engineering, Turkey

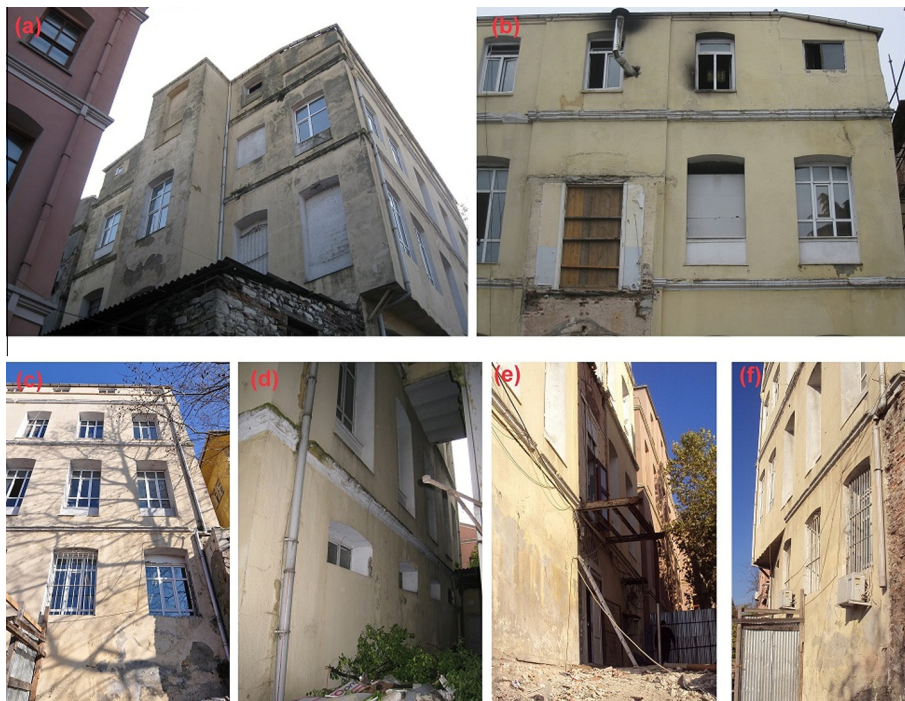
Fig. 1. Facade views of the structure the pre-restoration (a–f).

Preparing the restoration project, historical photos and old maps were utilized in collecting data and documents on the building facade; therefore, information on structure form, roof form, storey height of the building, roof patio, storey count, relationship with the neighbouring buildings and location of the windows was obtained [6–8]. Views of the historical building before the restoration are presented in Fig. 1.

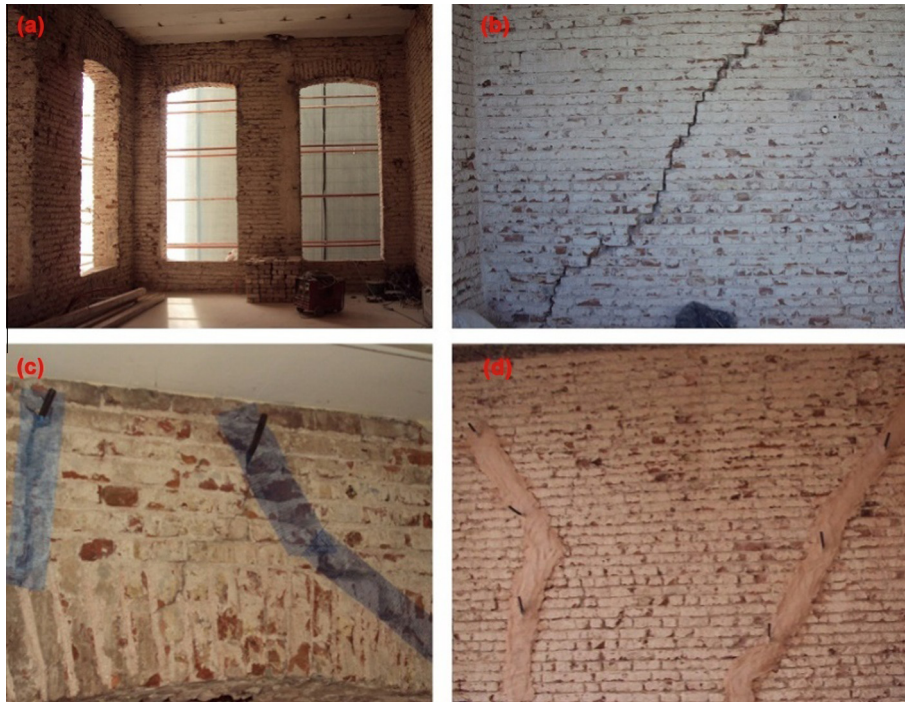
Fig. 7. Application of wall injection: (a) Examination of all the walls after the plaster removal, (b) Determination of structural cracks, (c) Preparation of the surface for injection, (d) Completing injection application with manual technique.

After completing plaster removal on all masonry walls, structural cracks were determined. In order to repair them according to the building's structure, mixture ratio determined in the laboratory for the samples taken was used. The said mixture was applied to the cracks by means of manual injection. Integration was ensured by using steel clamp members in larger cracks and anchorage elements on the walls were anchored by means of epoxy (Fig. 7).

Since it takes time to settle the injection compound into the wall, application was repeated on different times. The compound inside the pipe was penetrated into the interior walls in time, the pipes were continuously injected and this process continued until the gaps were filled.

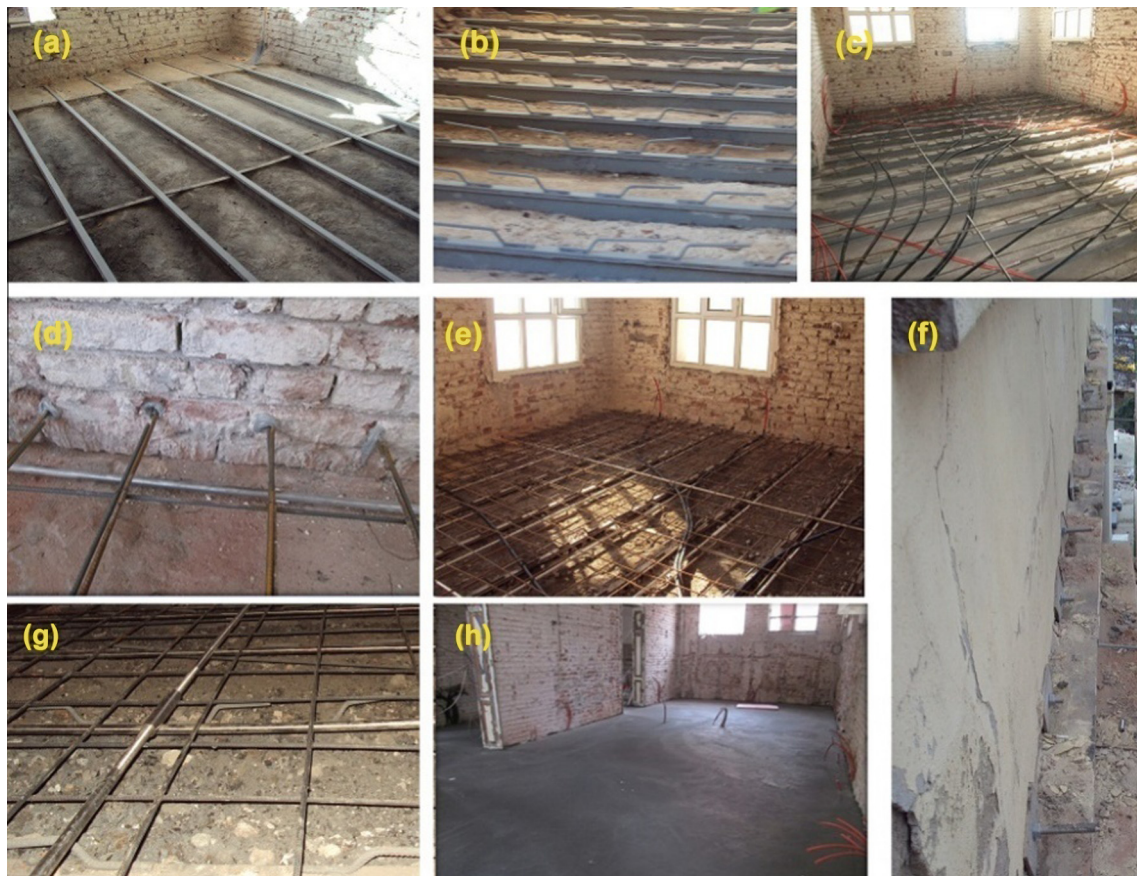
Fig. 8. Strengthening of the brick floor arches: (a) Removing top layers of the slab, adding $\phi 10$ shear rebar on the slab profile beam and painting with antirust paint, (b) Assembling shear rebars on the steel beams in the volta slabs, (c) Steel tie fabrication, (d) Planting the ores on the masonry walls, (e) Completing the welded wire fabrication, (f) Completion of the connections of stainless steel ties between the masonry walls, (g) Stretching the stainless steel profiles, (h) Topping concrete application on the slab.

- Covering on the brick floor arches were removed and the existing I profiles were revealed. Parts exposed to minor corrosion on the original volta slab steel profiles were cleaned, painted with double layer antirust paint and 10/40 mm lama profile was fixed by means of welding I profile to the top cover (Fig. 8a). The purpose of the lama profile fabrication is that the shear steel bar's welding thickness and surface are inadequate on the existing profiles.

- Ribbed shear steel rebar of $\phi 10$ was attached on the volta slab beams by welding (Fig. 8b).
- Using $\phi 20$ stainless steel tie members, masonry walls on the horizontal plane were integrated (Fig. 8c–e and g). The mentioned system passed through the masonry walls and fixed with 100/200/10 stainless plate and M20 bolt (Fig. 8f). Tensioning the stainless steel system was achieved by means of a geared system detail (Fig. 8g).

- Holes were drilled with a drilling core of $\phi 14$ and filled with epoxy in masonry walls. Steel rebar of $\phi 8$ was inserted in the drilled hole to support before the epoxy was set (Fig. 8d).

- Masonry walls with $\phi 8$ steel rebar anchorage and $\phi 10$ shear steel rebars fixed on the brick floor arches, wire mesh with $\phi 8/20$ were assembled. Thus, integration was ensured between the steel profiles in the brick floor arches, masonry walls and ribbed welded wire mesh system (Fig. 8e).

- After having completed the mentioned reproductions, topping concrete was applied on the volta slab (Fig. 8h).

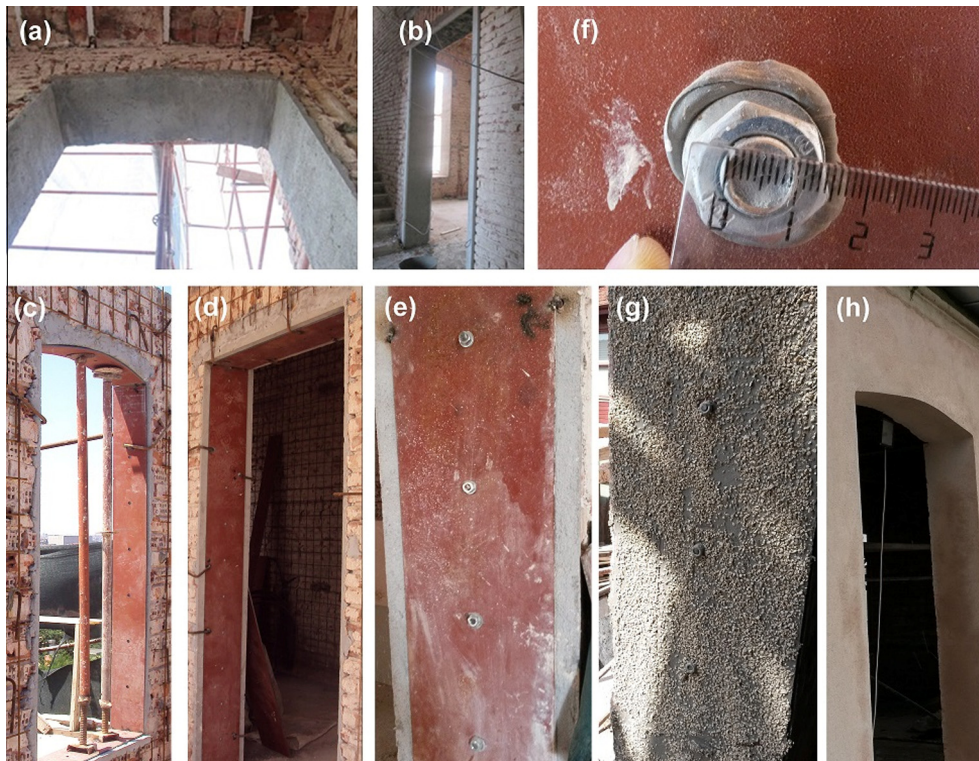
Fig. 9. Application of steel plate profiles on door and window gaps: (a and b) Composing a surface with polymer modified mortar with 3 cm thickness grout additive, (c–f) Steel plate assemble on door and window edge surfaces, (g) Preparing the surface for plaster application, (h) Plaster reproduction to conceal the steel plates.

- Copolymer primer was applied on masonry brick surfaces in window and door edges in order to create suitable surface for steel plate, afterwards, polymer modified mortar with 3 cm thickness grout-additive was applied (Fig. 9a and b).
- Steel plates of 8 mm thickness were assembled on the interior edges of door and window gaps (Fig. 9c and d).
- Anchorage holes were drilled with a drilling core of $\phi 12$ and filled with epoxy. Stainless steel rebar of $\phi 10$ was inserted in the drilled hole to support. Steel plate monolithic connections was made with stainless bolts (Fig. 9e and f).
- Steel plate surfaces were covered with epoxy and quartz sand was sprayed to make them ready for plaster application (Fig. 9g).
- Finally, plaster was applied to the steel surfaces and steel plates were hidden underneath the plaster (Fig. 9h).

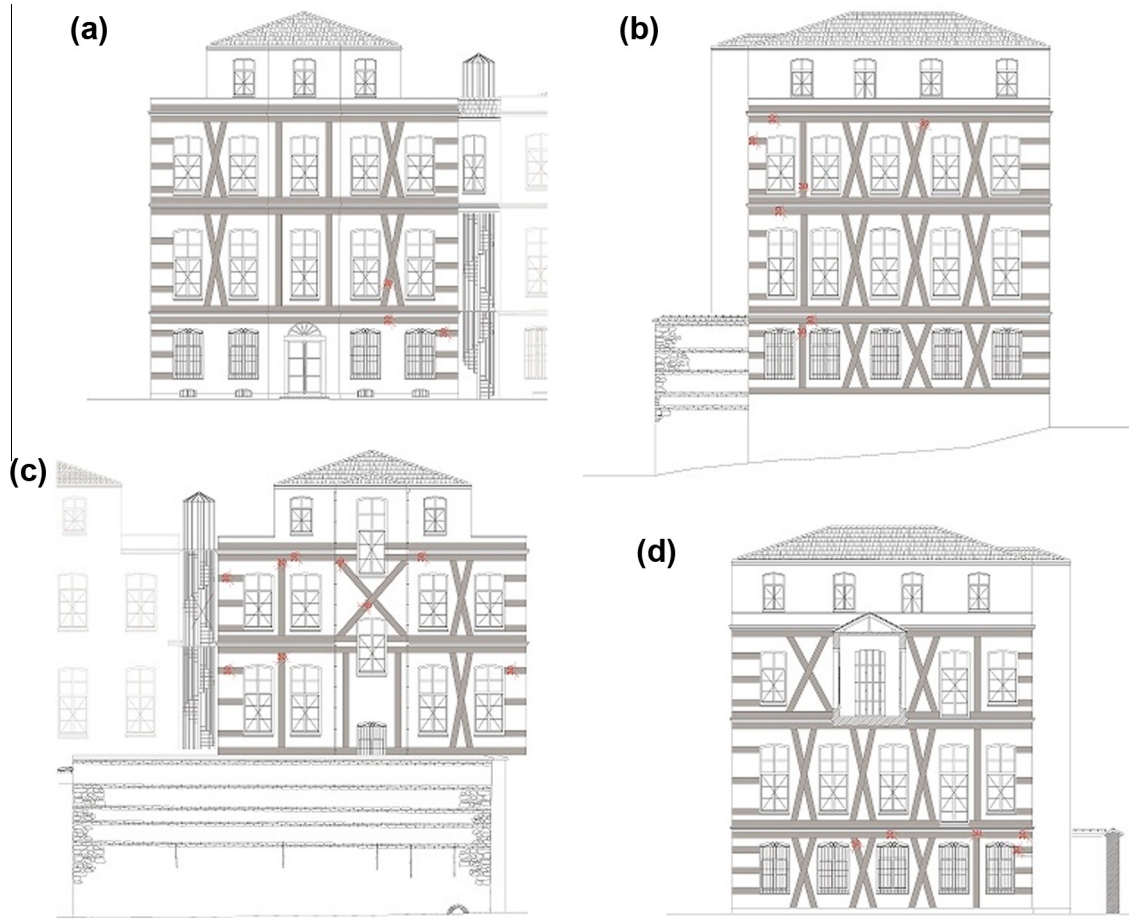
Fig. 10. Location of carbon fiber wrap application on four facades: (a) Southern facade, (b) Western facade, (c) Northern facade, (d) Eastern facade.

Following exterior facade plaster removal, injection was applied to improve the cracks. Carbon fiber wrap with 0.3 m width was used in tensile stress areas on the wall elements in order to resist the horizontal effects such as earthquake. Fig. 10 presents the applied carbon fiber locations on the facades. Carbon fiber wrap was positioned so that it would not affect window gaps and storey levels and concealed under lime-based plaster.

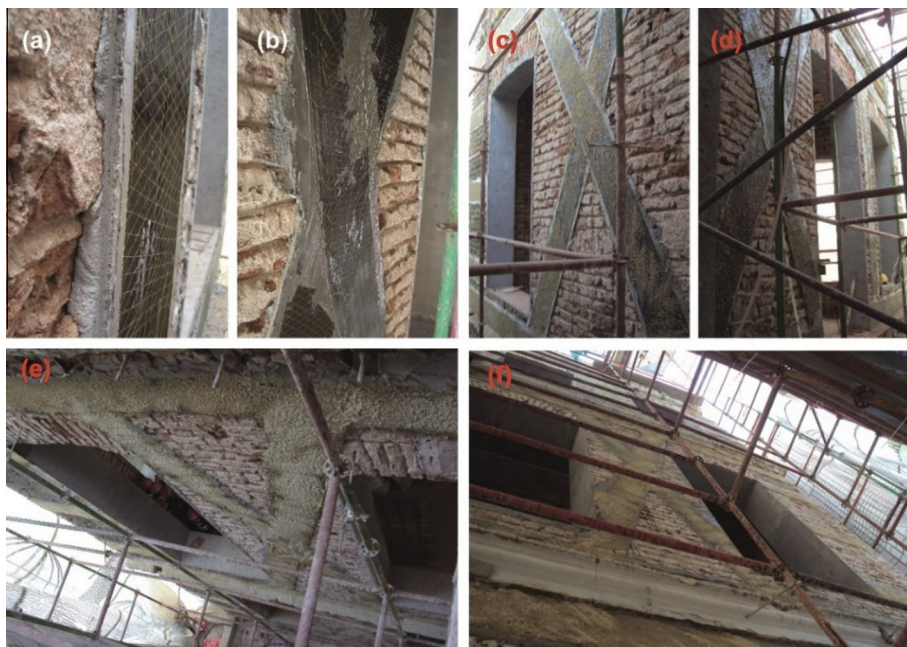
Fig. 11. Exterior facade application of carbon fiber wrap: (a and b) Detail of polymer modified mortar with 3 cm thickness, (c–f) Preparation by spraying quartz sand to make it ready for plaster.

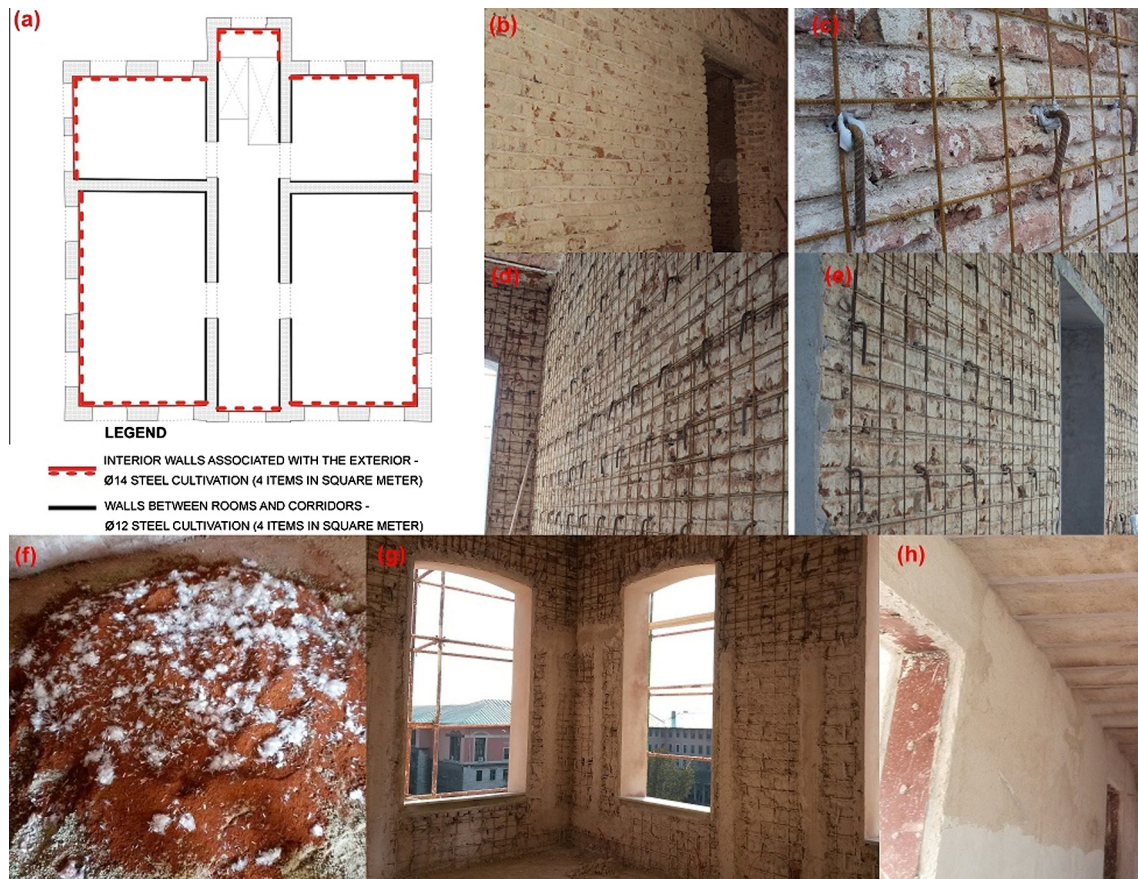
Fig. 12. Strengthening the internal walls with ore plantation method: (a) Strengthening locations of the first- and second-floor walls (interior), (b) View of the wall after plaster removal, (c–e) Strengthening the wall by using wire mesh, (f) Using polypropylene fibers in plaster content, (g) Application of thick plaster, (h) Application of thin plaster.
