Experimental evaluation of out-of-plane capacity of masonry infill walls

André Furtado^a, Hugo Rodrigues^{b,*}, António Arêde^a, Humberto Varum^a

^a CONSTRUCT – LESE, Department of Civil Engineering, Faculty of Engineering, University of Porto, Portugal

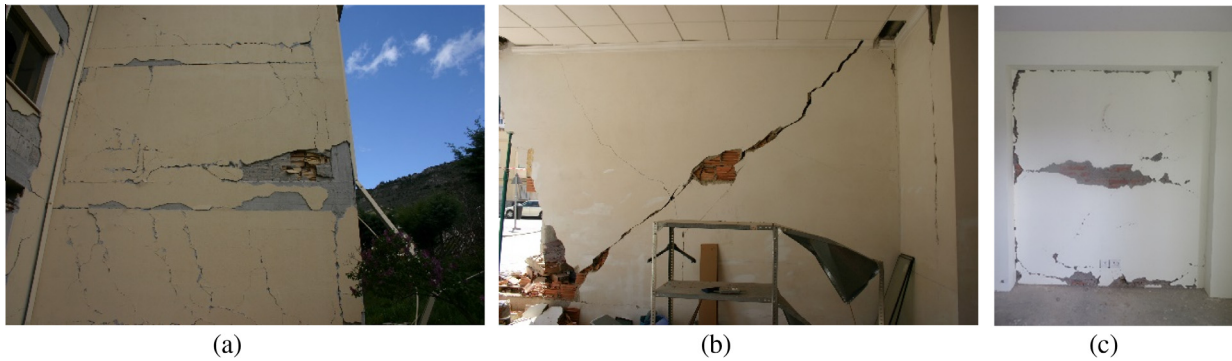
Fig. 1. Typical damage observed on in-plane IM walls: (a) detachment of the surrounding RC frame in the L'Aquila (Italy) earthquake, (b) diagonal cracking in Lorca (Spain) and (c) in the Nepal earthquake.

From the surveys of damaged and collapsed reinforced concrete (RC) buildings in recent earthquakes, a large number of buildings that suffered severe damage or collapse had their poor performance associated with the influence of the infill panels [8,9]. In some RC buildings subjected to seismic actions it is possible to observe that the major part of the structural elements has satisfactory behaviour with slight or no damage; however, their IM walls suffer much damage (in-plane or out-of-plane). Detachment of the IM panel from the surrounding RC frame, diagonal cracking as well as sliding cracking in the centre of the panel, shown in Fig. 1a–c are frequently observed.

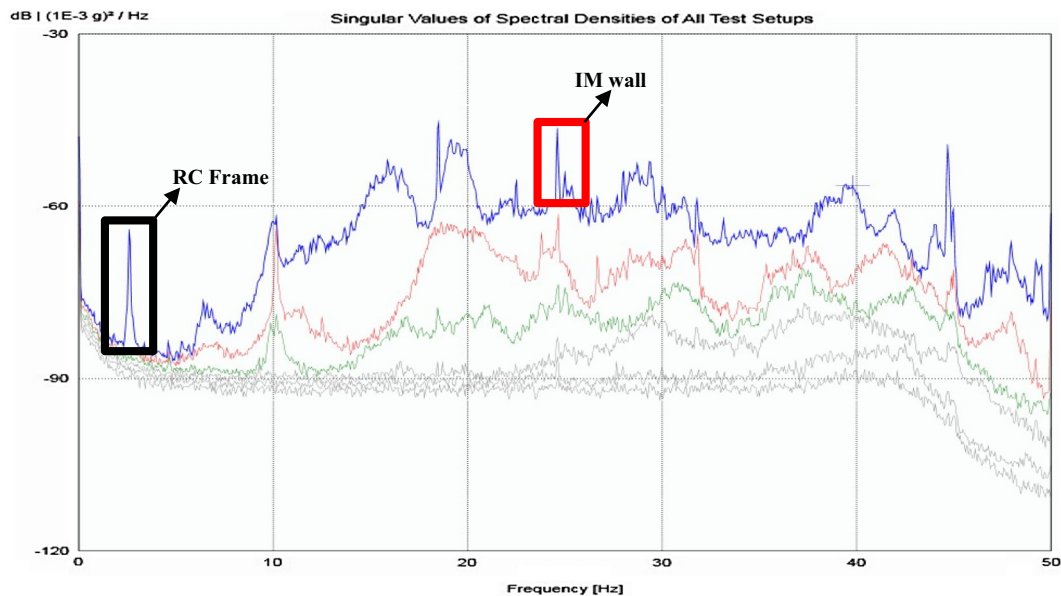
Fig. 8. Modal identification test: identification of the spectral peaks (Black – RC Frame and Red: IM wall). (For interpretation of the references to colour in this figure legend, the reader is referred to the web version of this article.)

Modal analysis of the specimens was subsequently carried out by means of the peak picking and frequency domain decomposition (FDD) techniques, implemented in the ARTeMIS Extractor software [22], from which the first natural frequency of every single wall was of 24.31 Hz for the 15 cm thick panels (illustrated red in the Fig. 8 and the corresponding vibration mode can be observed in Fig. 7b) and about 31 Hz for the 11 cm thick panels. Additionally, a spectral peak is observed about 4 Hz which corresponds to the first out-of-plane frequency of the RC frame (illustrated black in Fig. 8).

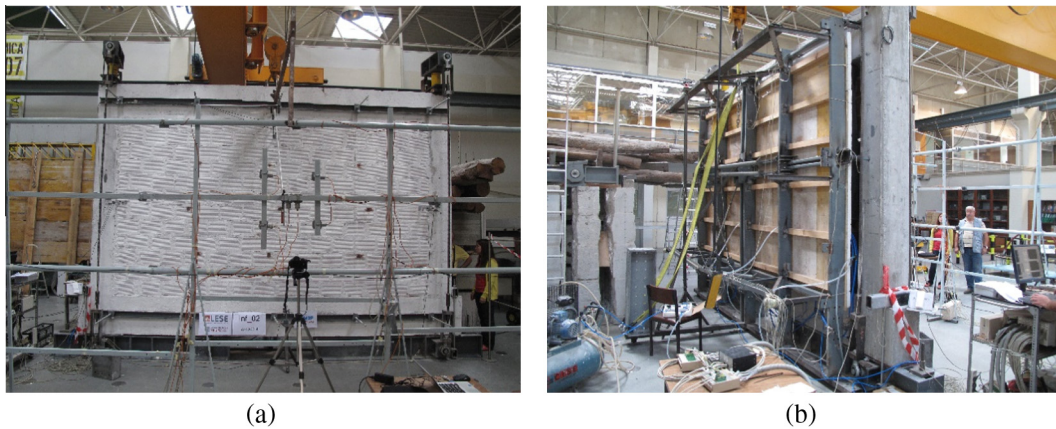
Fig. 10. General view of the out-of-plane experimental test set-up: (a) front view, (b) lateral view.

The out-of-plane test consisted of the application of a uniformly distributed surface load through a system composed of seven nylon airbags, reacting against a self-equilibrated steel structure, as shown in Figs. 9 and 10. The application of a uniform out-of-plane loading pretends (as was observed) to globally mobilize the out-of-plane response of the IM wall. In the literature similar out-of-plane load distribution adopted by other authors can be found [23,24].

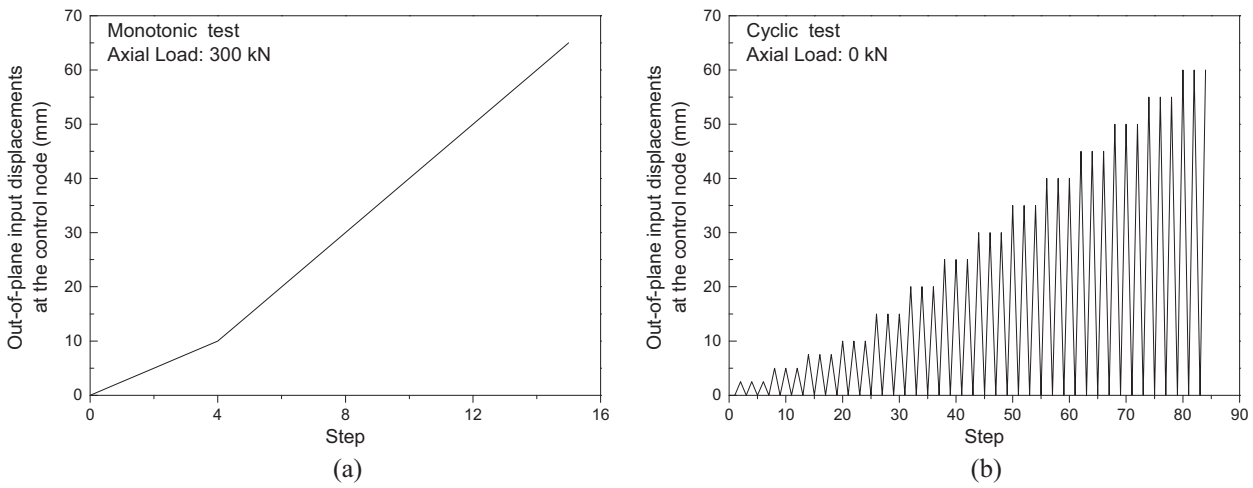
Fig. 12. Loading condition for: (a) monotonic test Inf_01 and (b) cyclic test Inf_02.

The Inf_01 test was carried out by imposing monotonic increasing out-of-plane displacements in the IM panel. With regard to the Inf_02 and Inf_03 tests, cyclic out-of-plane displacements were

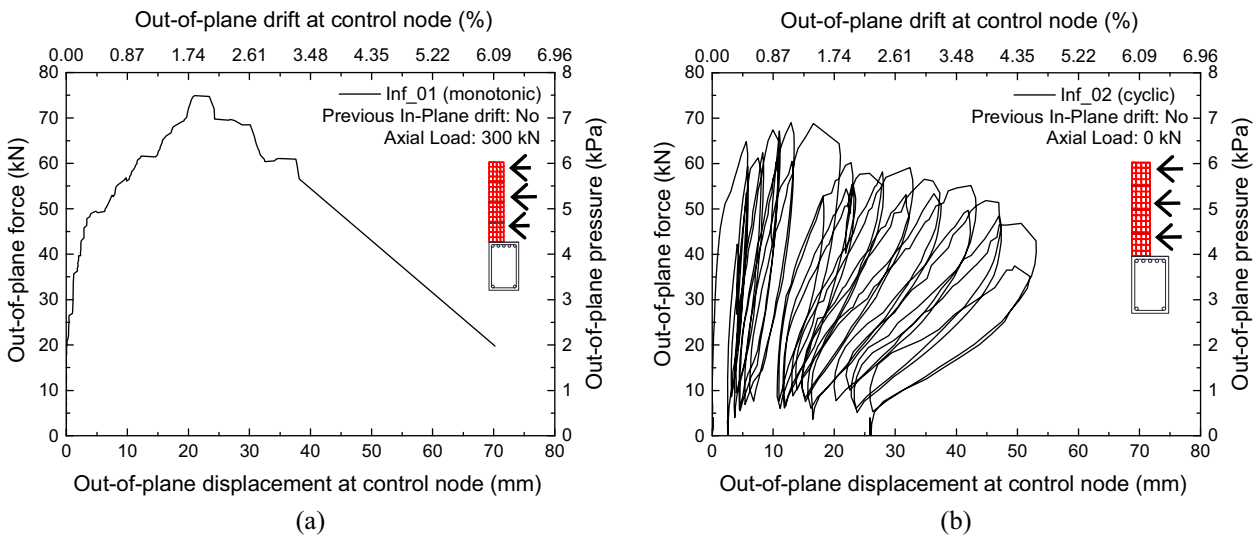
Fig. 13. Out-of-plane force–displacement test results: (a) Inf_01 and (b) Inf_02.

- The maximum strength was almost four times higher for the tests without previous in-plane damage (In_01 and Inf_02) and for higher out-of-plane drift values. For the Inf_01 and Inf_02 tests the maximum strength occurs for out-of-plane drift values of 1.5–2%.
- The strength degradation is particularly pronounced in both tests. This fact can be explained by the failure mode observed in this test (described below).
- By comparing Inf_01 and Inf_02, it was also verified that the initial stiffness of the IM walls was slightly affected by the axial loading in the RC columns. Namely, it was verified that the test with axial load (Inf_01) had about 5% more initial stiffness when compared with Inf_02.
- It was also verified that the initial cracking for the lower out-of-plane drift values for the Inf_02 was about 10%. The cracking force in both experimental tests was about 50 kN.

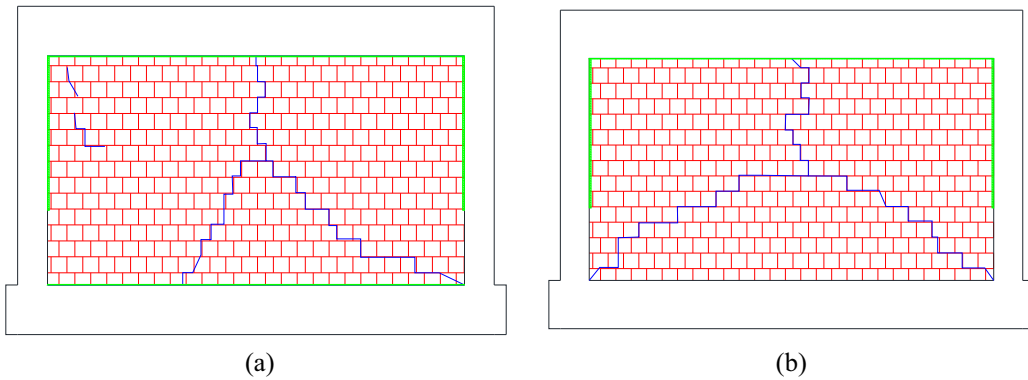
Fig. 15. Cracking pattern: (a) Inf_01 and (b) Inf_02.

Aiming for a detailed observation of the damage evolution during the experimental tests, within the present study each test was stopped at the end of the last cycle of each displacement level in order to highlight and register new cracks and/or the evolution of existing cracks. Visual observation of the damage evolution during the tests yielded the information described in the following paragraphs. The final damage patterns of all tests are presented in Figs. 14 and 15, showing several differences between the tests with and without previous in-plane damage. The final cracking shape of Inf_01 was vertical, with detachment between the infill panel and the surrounding RC frame in the top and bottom joints, as shown in Figs. 14a and 15a. However, the Inf_02 test exhibited a trilinear cracking pattern with deformation concentrated in the mid-point of the wall, with slight cracking in the top joint, as illustrated in Figs. 14b and 15b.

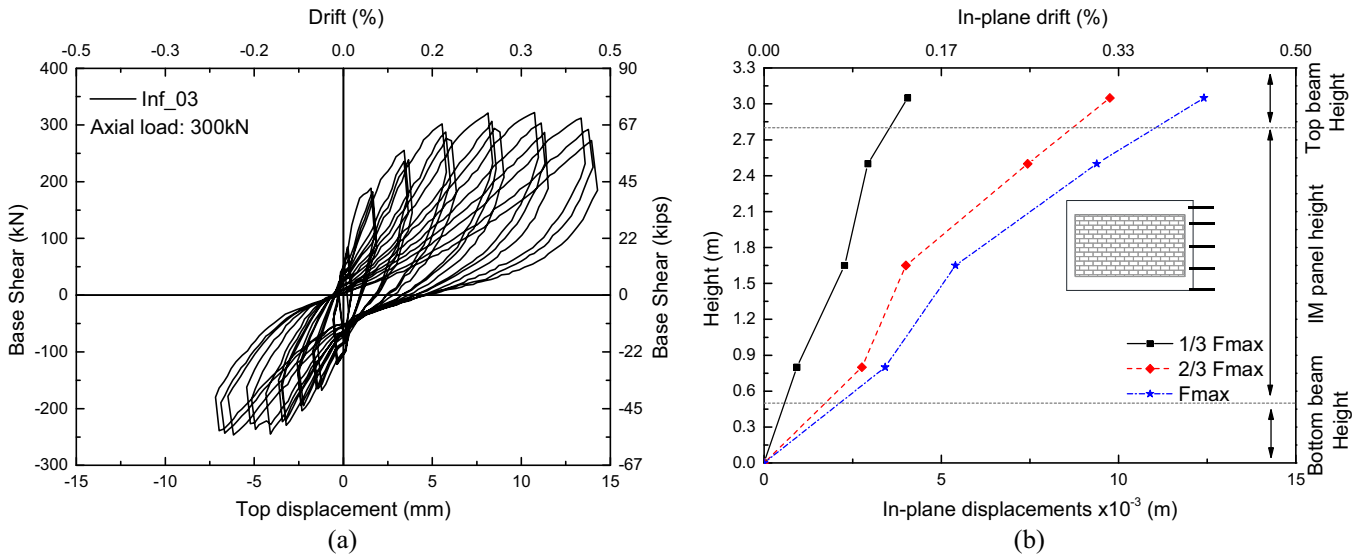
Fig. 22. In-plane test results of Inf_03: (a) force–displacement and (b) in-plane displacement profile.

From the analysis results of the force–displacement hysteretic curve (Fig. 22a) and the in-plane displacement profile (Fig. 22b), the following main observations can be drawn.

- The results between the positive and negative loading direction are non-symmetric, due to the longitudinal extension and slacks of the horizontal high strength rod during the experimental test. For this reason the positive loading will be adopted as the reference.
- A continuous increase was observed in the in-plane strength up to 0.25% drift, after which the strength stabilized until 0.5% drift, though with clear stiffness degradation during the test.

- The maximum strength was characterized by the onset of diagonal cracking in the weaker panel (110 mm thick) and detachment of the surrounding RC frame. At 0.3% drift it was possible to observe panel detachment relative to the top beam and also corner crushing in the stronger panel (Fig. 22).
