Experimental study on the progressive collapse performance of RC frames with infill walls

Sidi Shan^{a,b}, Shuang Li^{a,b,*}, Shiyu Xu^c, Lili Xie^{b,d}

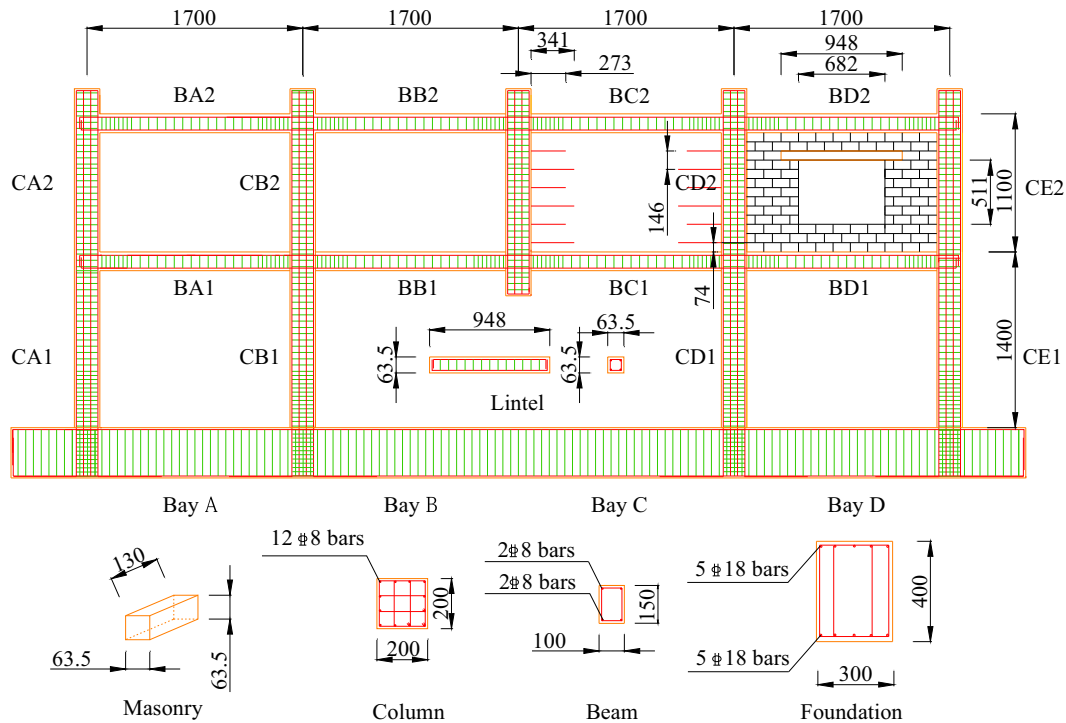
Fig. 1. Design details of test frame specimens (Bays A and B illustrate the case without infill walls; Bay C illustrates tie rebars between columns and infill walls; and bay D illustrates the case with infill walls. Unit: mm).

The geometry and reinforcement details of the two test specimens are given in Fig. 1. The design of the beams and columns in the two test specimens was identical. The difference between the two specimens was that in the first specimen there were no infill walls, while in the second the frame was infilled with walls with openings reserved for normal size windows. The left hand side (bays A and B) of Fig. 1 illustrates the geometry of the bare frame; that of the infilled frame is displayed on the right hand side (bays C and D). The center column in the first story was not presented in the structural design, to simulate the scenario of removal of column from the system due to accidental loads. Stirrups had 135 degree end hooks. Stirrups with a diameter of 4 mm were used in the end regions of the beams (within 250 mm measured from the beam end) at the spacing of 33 mm and in the middle regions of beams at the spacing of 67 mm. Stirrups with a diameter of 4 mm were used in the first story, at the spacing of 33 mm in the bottom regions of columns (within 450 mm measured from the column end) and 50 mm in other regions. The 8 mm (in diameter) stirrups at the spacing of 60 mm were used in the foundation beams. To improve the connectivity of the infill walls to the frame members, the 2 mm (in diameter) tie rebars with length 273 mm or 341 mm were used to tie the infill walls to the columns in the second story for the infilled frame [28]. The dimension of the masonry blocks were 130 mm × 63.5 mm × 63.5 mm. The average thicknesses of the horizontal and the vertical mortar joints were 8.9 mm and 5.8 mm, respectively. To mimic the practical construction sequence and schedule, the specimens were cast at three different times, for construction of the foundation, first story and second story, respectively. All of the beams and columns had a clear concrete cover of 15 mm. The material properties of the concrete, infill walls and rebars are given in Table 1.

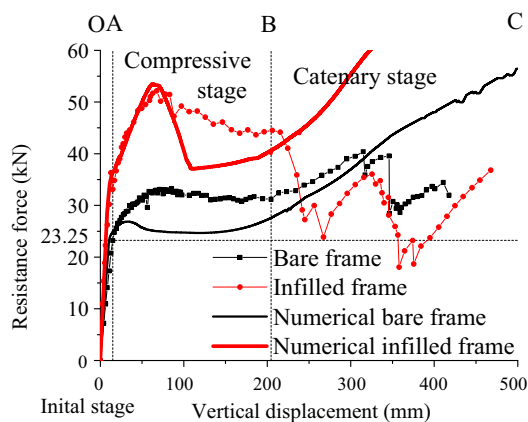
Fig. 4. Resistance force versus vertical displacement of the central column for the frames.

Fig. 4 shows the resistance force versus the vertical displacement of the center column for the bare frame. At the vertical displacement of 85.4 mm, the resistance force achieved its maximum value of 33.2 kN in the compressive stage, then gradually decreased to 31.2 kN until the end of the compressive stage (the vertical

displacement of 204.5 mm). Thereafter, because of the development of catenary action in the damaged structure, the resistance force increased again in the catenary stage until the end of test, in spite of several drops in its magnitude due to rebar fractures. The test ended when the center column attained the vertical displacement of 417.7 mm. Fig. 5 shows the horizontal displacements of joints at the adjacent and external columns (see Fig. 3, the locations of LVDTs) versus the vertical displacement of the center column. According to the recorded data as reported in Fig. 5, when the vertical displacement increased in the initial stage and compressive stage, the adjacent and the external joints firstly moved outward (i.e., horizontally away from the center column) and achieved their maximum values of approximately 3.8 mm at the vertical displacement of 106.6 mm. Next, these joints moved back to their initial positions (with a horizontal displacement of 0 mm) at the vertical displacements of approximately 204.5 mm. Thereafter, the joints continued to move inward until the end of test in the catenary stage. In the initial stage and compressive stage, the horizontal displacements of joints at the first and second stories were almost the same; in the catenary stage, the horizontal displacements of joints at the second story gradually exceeded those at the first story. At the end of the test, the average inward displacement of joints at the first story and the second story was 20.8 mm and 35.1 mm, respectively, and the latter was about 1.69 times the former.

Fig. 4 also shows the resistance force versus the vertical displacement of the center column for the infilled frame. From the vertical displacement of 12.8 mm to 14.9 mm, a drop in resistance force was occurred because of the cracks in the infill walls. It should be note that 14.9 mm is also assigned to the end of the initial stage for both of the frame specimens, because as for the bare frame, the vertical displacement about 14.9 mm corresponds to the formation of plastic hinges in beams by theoretical prediction. At the vertical displacement of 67.5 mm, the resistance force achieved its maximum value of 52.2 kN, then gradually decreased to 41.1 kN until the vertical displacement reached 224.5 mm. After that point, the resistance force dropped several times due to rebar fractures before it increased again owing to the catenary action. The test ended at the vertical displacement of 467.7 mm. Fig. 6 shows the horizontal displacements of joints at the adjacent and external columns versus the vertical displacement of the center column. Similar to the response of the bare frame, as the vertical displace-

The numerical simulation results were compared with those observed from the experiment in Figs. 4–6. The numerical response gave acceptable predictions for the overall behaviors of the frame specimens. However, the numerical maximum resistance force of the bare frame was smaller than the experimental value in the compressive stage. This was in part due to that the beneficial compressive arch action cannot be represented by the macro model using beam–column elements. The compressive stress of struts 1, 2 and 3, 4 in bay C is shown in Fig. 18. Struts 3 and 4 worked during the test, whereas struts 1 and 2 failed at the peak load. The reduction of compressive force in struts 1 and 2 caused decreasing in the resistance force of the infilled frame. To further investigate the effects of struts on the progressive collapse performance of infilled frames, the models with the compressive strength of struts 1, 2 and 3, 4 scaled from 0.5 to 1.5 times were compared in Fig. 19. It can be seen that the maximum resistance force was enhanced, with increasing the compressive strength of struts 1 and 2. However, the overall behavior only has slightly change as the compressive strength of struts 3 and 4 was increased.

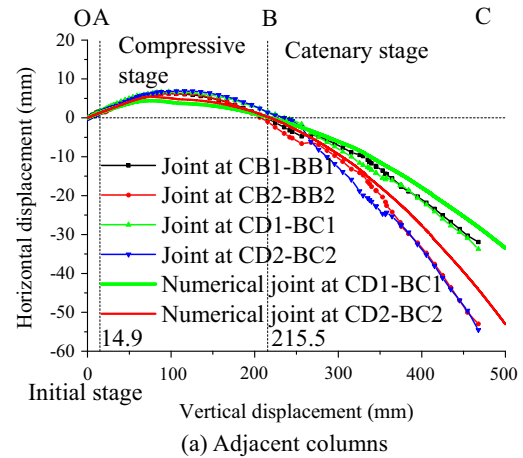
Fig. 5. Horizontal displacements of joints versus vertical displacement of the central column for the bare frame.

ment increased, the adjacent and external joints firstly moved outward and achieved their maximum values of approximately 6.8 mm at the vertical displacement of 106.3 mm. Then, the joints moved back to their initial positions (with a horizontal displacement of 0 mm) at the vertical displacements of approximately 215.5 mm (the end of the compressive stage and the start of catenary stage). Thereafter, the joints continued to move inward until the end of test. In the compressive stage, the horizontal displacements of joints at the first and second stories were almost the same, but in the catenary stage, the horizontal displacements of joints at the second story gradually exceeded those at the first story. At the vertical displacement of 415.3 mm, approximately at which point the test for the bare frame ended, the average inward displacement of joints at the first story and second story was 22.1 mm and 37.3 mm, respectively, and the latter was about 1.69 times the former. The maximum outward horizontal displacements of the adjacent and external joints were observed to be approximately 1.79 times those of the bare frame, whereas the maximum inward horizontal displacements of joints were only approximately 1.06 times those of the bare frame when compared at the vertical displacement of 417.7 mm.

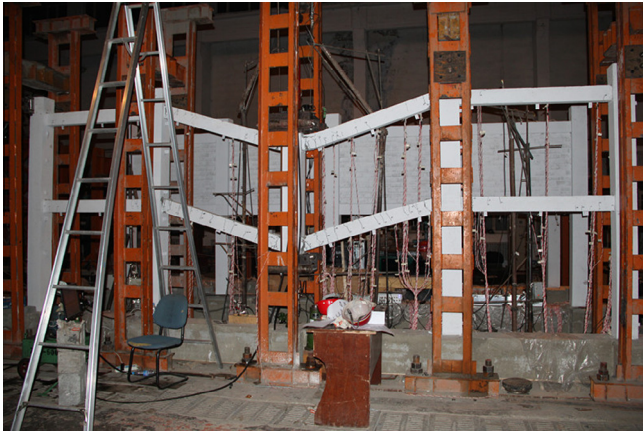
Fig. 9. Failure mode of the bare frame at the end of the test.

test, are shown in Fig. 8. It is seen that there were only slight cracks in those beams. The final failure mode of the bare frame at the end of test is shown in Fig. 9, in which the damage was mostly concentrated in the beam ends in bays B and C, while the damage to beams in bays A and D was slight.

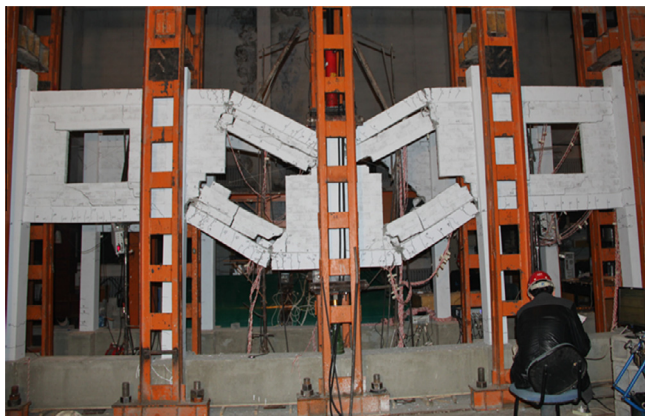
Fig. 12. Failure mode of the infilled frame at the end of the test.

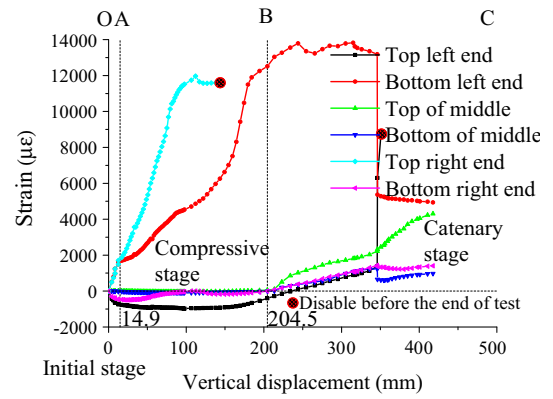
(a) Beam BC1

(b) Column CD1

Fig. 13. Strains of rebars in beam and column for the bare frame.

Fig. 13a shows the strain variations of rebars in beam BC1 for the bare frame. It is observed that the rebars in the bottom of left

end of the beam and those in the top of right end of the beam were in tension during the test. On the contrary, initially, the rebars in the top of left end, bottom of right end and in the middle of beam were in compression in the initial and compressive stages. When the vertical displacement reached 204.5 mm (the beginning of catenary stage), the strains in these rebars gradually changed from compression to tension due to the development of catenary action. After the vertical displacement of 346.3 mm, the stress in rebars in the bottom of left end sharply dropped because of rebar fracture processes. Meanwhile, the stress in rebars in the top of left end considerably increased because the tension forces were transferred from the fractured rebars to un-fractured ones. Fig. 13b shows the strain variations of rebars in the bottom end of column CD1. It can be observed that in compressive stage, the left side in the bottom end of column CD1 was in tension and the right side was in compression. In the catenary stage, the left side shifted into compression and the right side into tension. This reconfirmed the change of direction of the joint’s movement from outward to inward during the test.

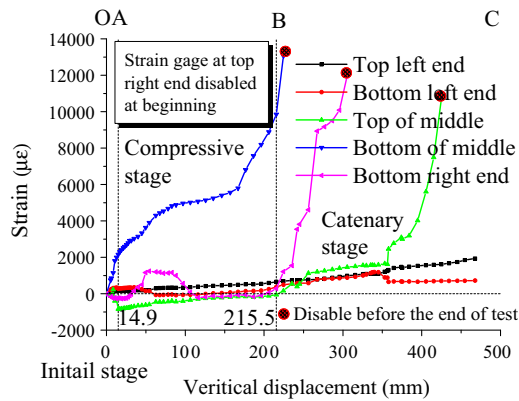
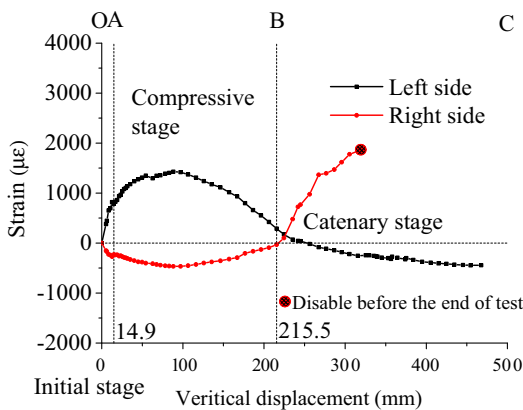
(a) Beam BC1

(b) Column CD1

Fig. 14. Strains of rebars in beam and column for the infilled frame.

Fig. 14a shows the strain variations of the rebars in beam BC1 for the infilled frame. It is seen that the rebars in the bottom of middle of beam were in tension during the test. The rebars in the top of middle and bottom of right end changed from compression into tension due to the occurrence of catenary action. Unlike the strains in the bare frame, strains were concentrated in the right

part of beam BC1, and strains in the left end of beam BC1 were small during the whole test. This proved that the load distribution was changed in the infilled frame and the deformation of beam BC1 was concentrated in the right part due to the contribution of equivalent compressive strut mechanism. The phenomena will be further discussed in the later Section 3.4.2. Fig. 14b shows the strain variations of the rebars in the bottom end of column CD1. It can be observed that at the beginning of test, the left side in the bottom end of CD1 was in tension and the right side was in compression. Later, due to the catenary action, the left side shifted into compression and the right side into tension.

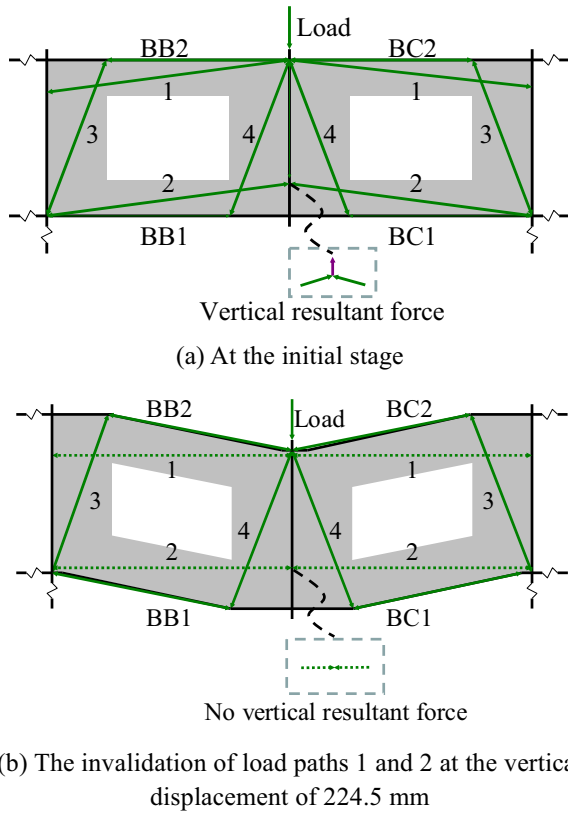
Fig. 16. Alternative load paths in bays B and C for the frame with infill walls.

As illustrated in Fig. 16, the infill walls in the bays bridging the center column (i.e., bays B and C) can be seen as four equivalent compressive struts, and each strut provided an alternative path for load transfer. One portion of load on the center column transferred from beams BB2 and BC2 and then through struts 3 to adjacent bays, and another portion of load transferred from struts 4 and then through beams BB1 and BC1 to adjacent bays. Load was transferred to the adjacent resisting elements thanks to the axial and flexural stiffness of the beams, and to the compressive actions in the struts. Because of the alternative load paths, unlike the bare frame, relative small portion of load was transferred in the beams at the region above the struts 3 and below the struts 4. These explain the different failure modes and different strains development in beam BC1 between the infilled frame and bare frame.

The other portion of load on the center column was transferred through struts 1 and 2 to the adjacent bays by the form of axial compressive force. Because of the cracks development and the change of direction of the struts 1 and 2, the effects of struts 1 and 2 reduced as the vertical displacement increased. These explain the resistance force decreasing from the vertical displacement of 67.5 mm to 224.5 mm.

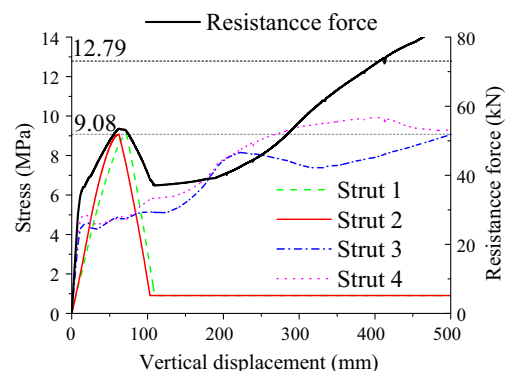
Fig. 18. Axial force of struts 1, 2, 3, and 4 in bay C.
