Experimental assessment of unreinforced exterior beam–column joints with deformed bars

Maria Teresa De Risi, Paolo Ricci*, Gerardo M. Verderame, Gaetano Manfredi

Department of Structures for Engineering and Architecture, University of Naples Federico II, Naples, Italy

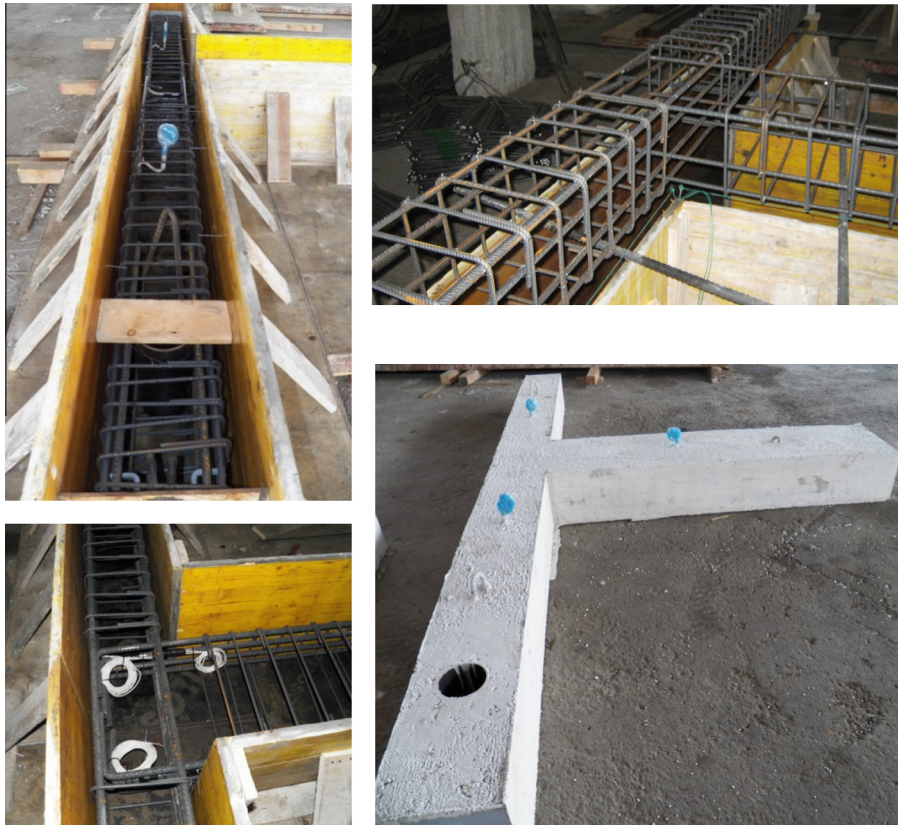
Fig. 2. Construction of specimens.

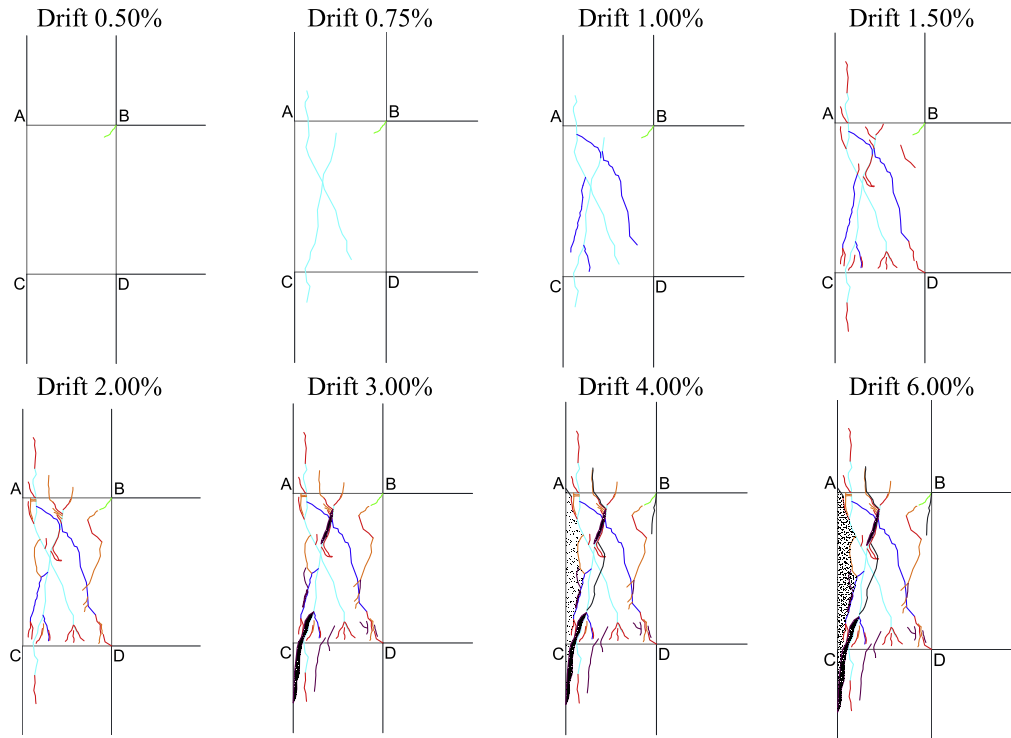
Fig. 7. Evolution of damage – Test #1.

In Fig. 7 the evolution of joint panel damage state is visually reported and a more severe cracking pattern can be observed along the diagonal A–D. Fig. 8 shows the final damage state of the specimen. (i) the significant damage of joint panel, (ii) the spalling of concrete cover away from the lateral side of joint; (iii) no buckling of column longitudinal reinforcement in the joint region, and (iv) a limited crack width at beam–joint interface can be noted. Table 4 summarizes the evolution of the observed damage for Test #1 described above.

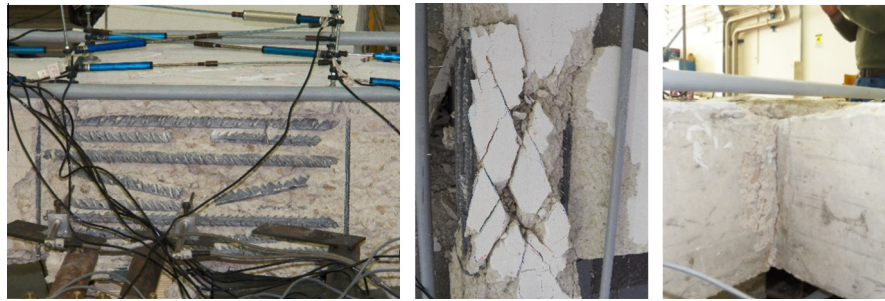
Fig. 8. Final damage state: joint panel and beam–joint interface – Test #1.

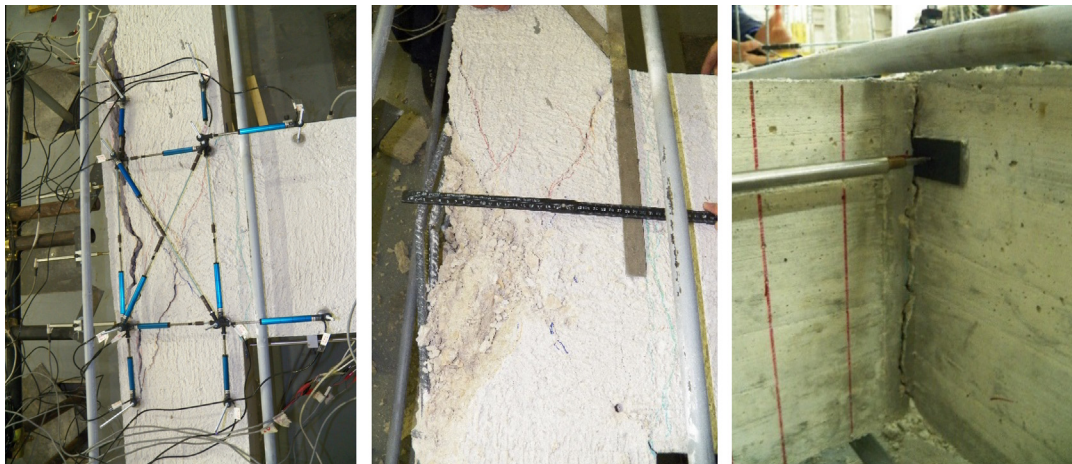
Fig. 11. Final damage state: joint panel and beam–joint interface – Test #2.

Fig. 11 shows the final damage state of the specimen. (i) a severe damage level of the lateral side of joint caused by concrete cover spalling; (ii) the sudden buckling of column longitudinal

reinforcement in the joint region, (iii) the quite moderate damage level in the joint panel, and (iv) a more important crack width at beam–joint interface with respect to Test #1 can be noted. Table 5 summarizes the evolution of the observed damage for Test #2.

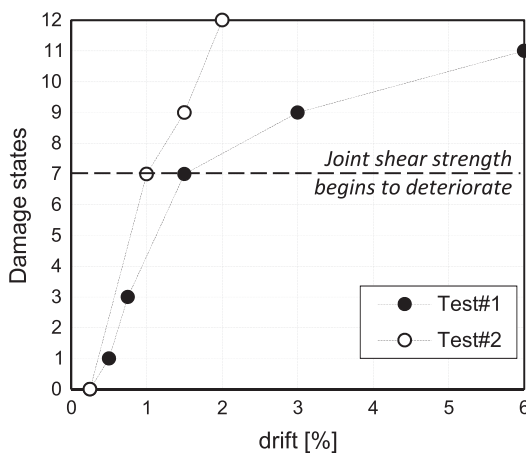
Fig. 13. DSs according to Pagni and Lowes [31].

As suggested by Pagni and Lowes [31], DS at each applied drift level is defined on the basis of: cracking pattern, peak shear strength, yielding of beam longitudinal reinforcement (if any), cracks opening (where possible), concrete spalling, and buckling of column longitudinal reinforcement (if any). In particular, the more severe DS that can be recognized at each drift level is plotted in Fig. 13 for both tests.

It can be noted that Test #1 shows a gradual increase in damage level, starting from hairline cracks at beam–joint interface (DS0) and cracks in the joint core (from DS1 to DS3) up to cracks extension in columns (DS9) and, finally, a quite distributed crushing of concrete in the joint core (DS11) and cover. Note that DS7 corresponds to the achievement of the peak strength and the beginning of joint shear strength degradation (as it will be shown also in Section 4).

Vice-versa, in Test #2 the evolution of damage is faster, from DS0 to buckling of column longitudinal reinforcement (DS12). In this case, first joint cracking (DS1–DS3) and beam longitudinal reinforcement yielding (DS4) occur at the same drift level than DS7.

Fig. 13 clearly shows that, at a given drift level, DS is higher for Test #2 than for Test #1, confirming the faster damage evolution for Test #2.

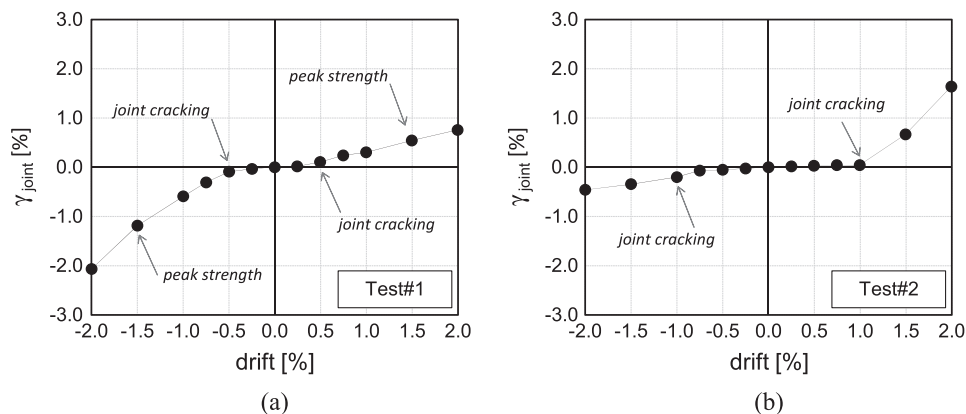
Fig. 17. γ_{joint} versus global imposed drift: Test #1 (a) and Test #2 (b).

In Test #1 the shear strain of the joint panel rapidly increases after joint cracking (drift = 0.50%). When the peak strength is attained (drift = 1.50%) the maximum γ_{joint} is equal to 1.19% and increases up to 2.07% in post-peak phase (at 2.00% drift). Again, the higher deformability under negative imposed displacements is observed.

In Test #2, too, the shear strain is not significant until joint cracking occurs. In post-cracking (or post-peak) phase, γ_{joint} increases rapidly up a maximum value of 1.64% (at 2.00% drift). In this case, a higher deformability under positive imposed displacements is observed, as previously described.

Summarizing, in the post-cracking phase of the joint panel, given a fixed drift level, higher values of γ_{joint} are observed in Test #1 (J-failure) compared with Test #2 (BJ-failure), as it will be better explained in Section 4.3.

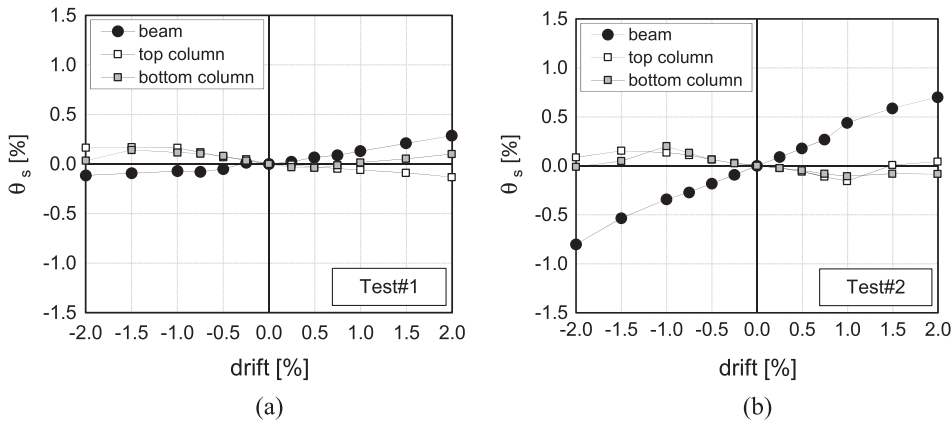
Fig. 19. Rotation θ_s related to beam, top column and bottom column: Test #1 (a) and Test #2 (b).

Experimental data are plotted until the support points of the corresponding LPs were affected by significant cracks (i.e., when a drift value equal to 2.00% was reached). As for γ_{joint} in Fig. 17, also θ_s is evaluated at the end of the first sub-cycle for each drift value. In both tests, it can be observed that θ_s is generally lower for the columns than for the beam.

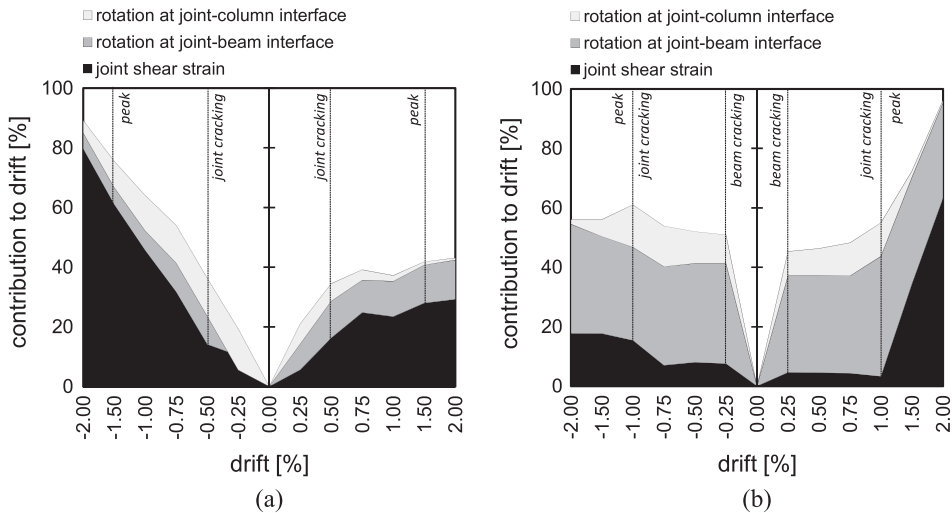
Fig. 20. Contributions to the overall imposed drift: Test #1 (a) and Test #2 (b).

For Test #1 (Fig. 20(a)) – which exhibited a J-failure mode – θ_{joint} reaches a maximum of 70% of the imposed drift at the peak point

(drift = 1.50%) and about the 80% at 2.00% drift (in negative loading direction). In particular, after the cracking of the joint panel (drift = 0.50%), the shear strain contribution due to γ_{joint} is systematically predominant with respect to the contribution due to rotation at the beam(column)/joint interface.

For Test #2 (Fig. 20(b)) – which exhibited a BJ-failure mode – θ_{joint} reaches a maximum value of about 95% at 2.00% drift (positive loading direction). The contribution due to rotation $\theta_{s,b}$ is the main contribution to θ_{joint} until cracking of the joint panel occurs. Vice-versa, after cracking of joint, the contribution of γ_{joint} rapidly increases, while $\theta_{s,b}$ is almost constant, despite yielding of longitudinal reinforcement.

Such trends are consistent with the expected deformation mechanisms, based on the observed failure modes. Finally, the contribution that misses to reach 100% in Fig. 20 is due to flexural deformability of beam and columns, and progressively reduces its weight for increasing drift levels.
