# Experimental seismic behavior of innovative composite shear walls

In this paper, an innovative structural wall, named bundled lipped channel–concrete (BLC–C) composite wall, is proposed. The proposed wall consists of bundled lipped channels seam-welded together and in-filled concrete. Seven full-scaled specimens were tested under axial load subjected to cyclic lateral load. The variables studied in the experiments include the configuration of the walls, the axial load ratio, the presence of shear studs, and the loading history. The specimens exhibited ductility and experienced stable hysteresis behavior. The specimens failed in the sequence of local buckling of the steel sheet, and the propagation of the fractures at the boundary of the wall. The seismic behavior of the specimens was evaluated in terms of strength, stiffness, deformation, ductility, and energy dissipation capacity. The results indicate that the level of axial force ratio and the configuration detail significantly affect the entire hysteresis performance, while the presence of shear studs delays the occurrence of fracture and failure.

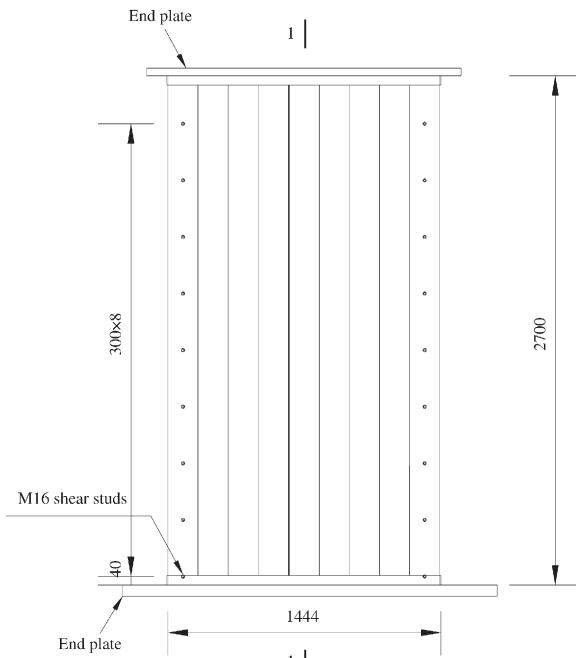
(f) Front view of Specimen BLC-C-5

Specimens BLC–C-1 and BLC–C-2 have identical properties except that the axial force ratios for Specimen BLC–C-1 and BLC–C-2 are 0.4 and 0.7, respectively. The specimens with a cross-section of 1324 mm × 130 mm consists of two 160 mm × 130 mm × 4 mm lipped channels at the two boundaries and five 200 mm × 130 mm × 4 mm lipped channels in the middle as given in Fig. 1(a). The adjacent channels are connected by complete joint penetration (CJP) welds along the seams. A steel sheet with the thickness of 4 mm was used in the middle of the wall where no vertical stiffener exists and thus, the BLC–C composite wall is divided into several compartments by the webs of the channels and the sheet. In order to facilitate the filling of concrete inside, a series of 45 mm × 80 mm slot holes are drilled in advance on both the webs of the channels and the steel sheet. The detailed location and dimension of the holes is illustrated in Fig. 1(h).

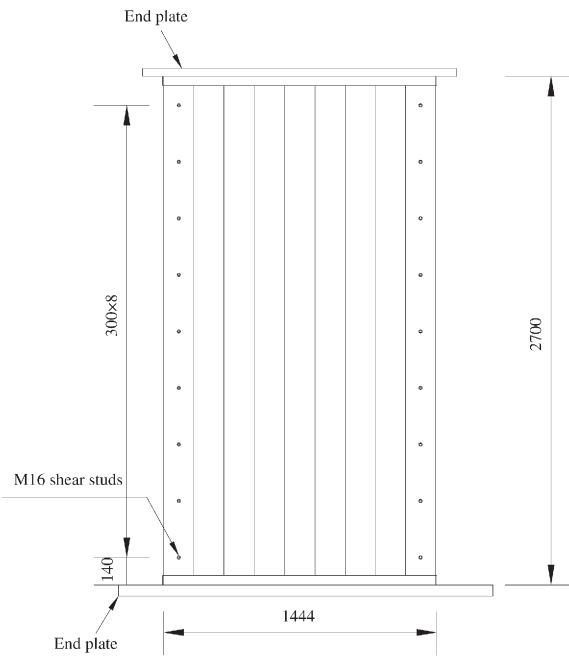
(g) Back view of Specimen BLC-C-5

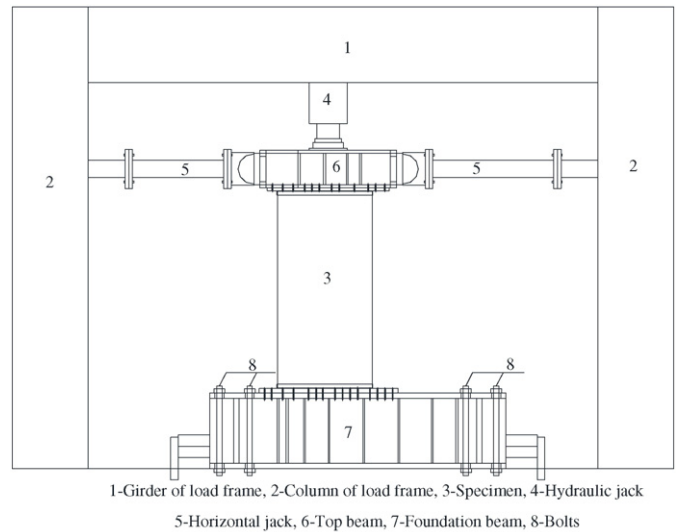
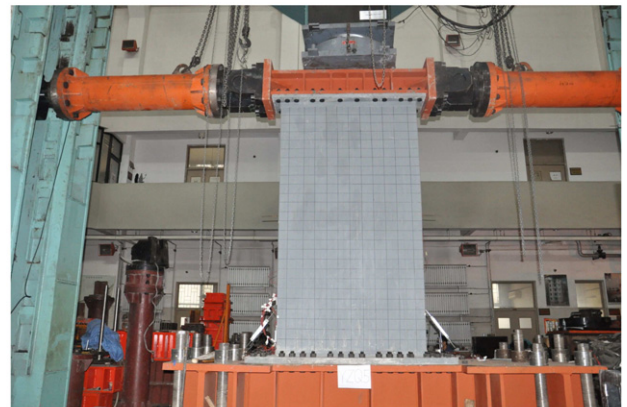
**Fig. 2.** Test setup. (a) Schematic view. (b) On-site photo.

(a) Schematic view

(b) On-site photo

The specimens were tested by the 20,000 kN multi-functional loading device in Tsinghua University. The vertical and the horizontal loading capacities of the device were 20,000 kN and 3500 kN, respectively. The general arrangement of the test setup is illustrated in Fig. 2. The specimen was placed in a steel loading frame. In order to enhance the connecting parts and prevent the fracture of the welds during the loading process, steel sheets with a width of 50 mm and a thickness of 6 mm were welded around the top and bottom of the wall. Additionally, two end plates with a thickness of 60 mm and 40 mm, respectively, were connected to the bottom and top of the wall by full penetration welds. The bottom plate and top end plates were bolted to the foundation beam and the top beam, respectively. The foundation beam was clamped to the reaction floor by ground anchor. The top beam was clamped to two hydraulic actuators, both in the horizontal directions. The hydraulic actuator in the vertical direction was fixed in the loading frame and meanwhile, was simply placed on the top beam. The friction between the vertical actuator and the top beam, which accompanies with the cyclically changing horizontal displacement during the test, was subtracted from the total horizontal (lateral) force provided by the horizontal actuators to obtain the actual lateral force on the specimen. This was achieved by using the strain cell in the loading device to measure the strain change which can in addition, be converted to the frictional force. The cylindrical bearing in the vertical actuator prevented itself from burdening the moment that might be induced by the friction.

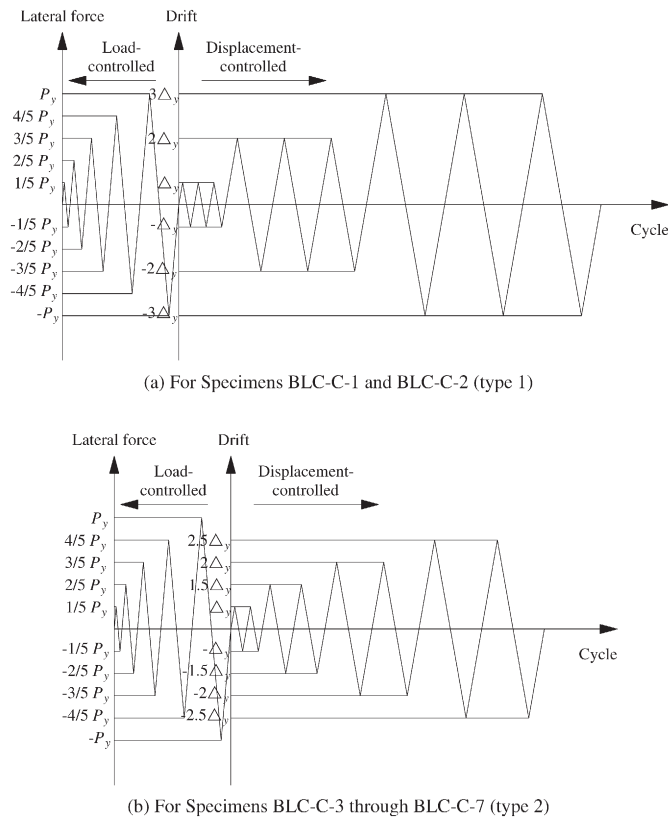
Fig. 3. Loading history. (a) For Specimens -1 and -2. (b) For Specimens -3 through -7.

1. More intensive loops can be observed in Specimens -3 to -7 than in Specimens -1 and -2. This is caused by the different loading histories. An interval of  $1D_y$  was imposed to Specimens -1 and -2 while an increment of  $0.5D_y$  was applied to the rest of the specimens.

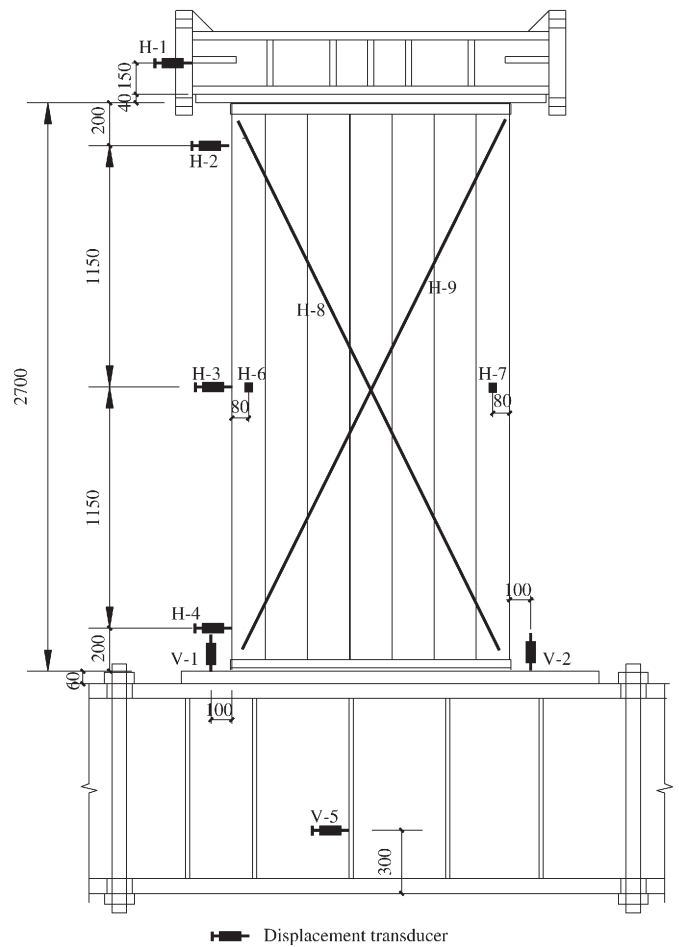
Fig. 4. Arrangement of displacement transducers.

The lateral and vertical loads applied on the specimen were automatically recorded by the load cells in the hydraulic actuators. Eleven displacement transducers (DTs) were mounted to measure the global and local deformations of the specimen. DT H-1 was placed at the top with the same height of the loading point to monitor the lateral displacement of the specimen. DTs H-2, H-3 and H-4 measured the lateral displacements along the height of the wall. DTs H-5, V-1, and V-2 were mounted on the foundation beam. DT H-5 was used to measure the horizontal slippage of the foundation beam along the direction of the lateral force, and the other two were applied to measure the rotation that may be caused by the potential uplift of the foundation beam from the reaction floor. DTs H-6 and H-7 were installed to monitor the possible out-of-plane deformation of the specimen. One pair of diagonally arranged DTs H-8 and H-9 was used to measure the shear deformation of the wall. The layout of the displacement transducers is illustrated in Fig. 4.

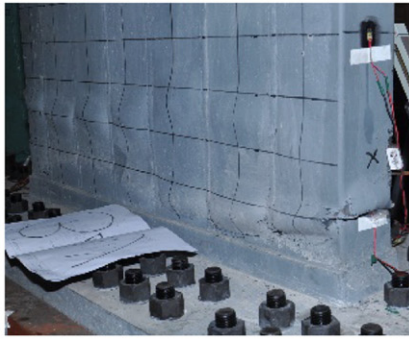
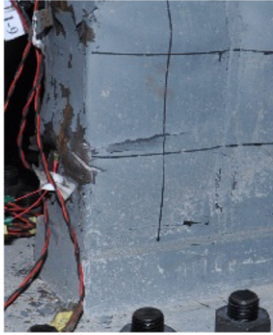
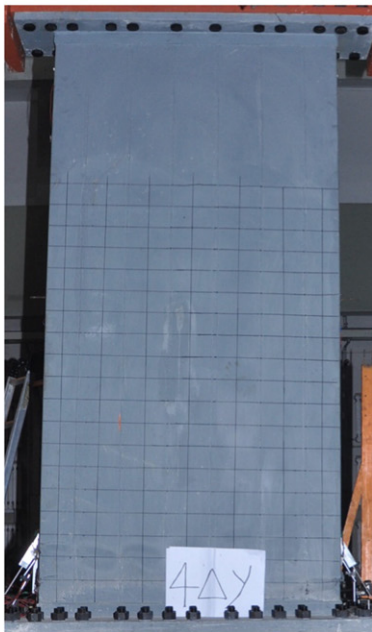
**Fig. 5.** Failure of Specimen -1. (a) Severe buckling and concrete crushing. (b) Horizontal crack in the weld. (c) Failure photo.

(a) Severe buckling and concrete crushing

(b) Horizontal crack in the weld

(c) Failure photo

of 150 mm and 350 mm from the bottom. By the end of the 1st cycle, buckling totally developed around the specimen at the height of 150 mm and 350 mm. After the 2nd cycle of the drift of  $1/45$  rad, fracture occurred at the bottom of the boundary of the specimen. Simultaneously, the concrete was crushed at the height of 150 mm, as shown in Fig. 5(a). Small fractures were observed on the other side as seen in Fig. 5(b). A horizontal crack also developed in the CJP weld that was used to connect the adjacent lipped channels. The lateral force was reduced to 70% of the maximum capacity of the specimen, and the specimen was considered failed. The test stopped. The failure photograph of Specimen -1 is shown in Fig. 5(c).

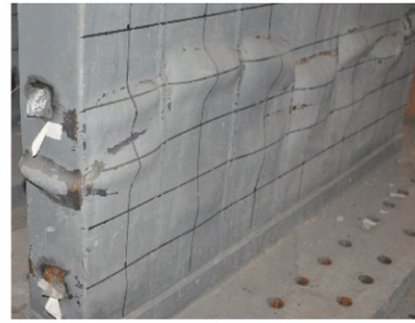
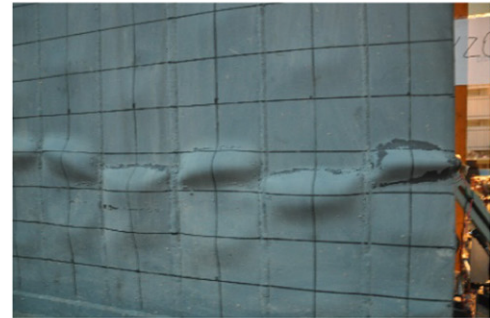
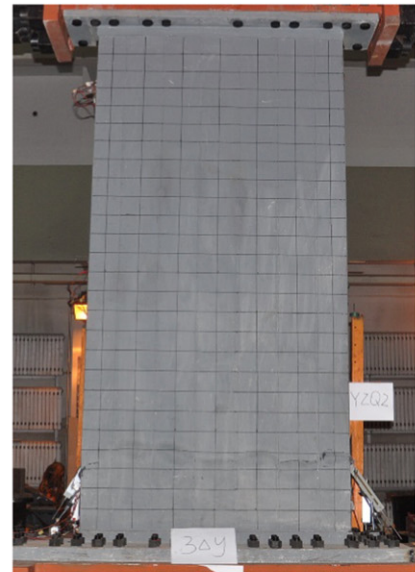
**Fig. 6.** Failure of Specimen -2. (a) Local buckling from the side view. (b) Local buckling from the front view. (c) Failure condition.

(a) Local buckling from the side view

(b) Local buckling from the front view

(c) Failure condition

For Specimen -2, the axial force ratio of 0.7 was applied. In the process of applying the vertical load, slight sound could be heard at the axial vertical force level of 3500 kN. No physical phenomenon was observed at this stage. The sound became larger when the vertical load arrived at 4000 kN. It was found that slight buckling had occurred at the bottom of the specimen, which means that the specimen had begun to develop yielding under such high axial force ratio. The predicted yield shear force of 794 kN was considered as the yield strength, and the corresponding lateral displacement of 14 mm was regarded as the yield displacement. It should be noted that the defined yield strength in the process of this experiment differs from the actual yield strength that was determined in the analyses. In the loading group of 14 mm displacement, no apparent deformation was observed. During the 1st positive loading cycle of the displacement of 28 mm ( $2D_y$ ), some slight buckling occurred at the height of 150 mm and 300 mm from the base. In the 2nd positive loading cycle, five locations near the base developed local buckling when the lateral force reached 985 kN. One more location began to buckle during the 2nd negative loading cycle. At the 3rd negative loading cycle, the specimen had noticeable local buckling at the height of 300 mm and the steel sheet dwelled off for about 2 mm in maximum, as shown in Fig. 6(a) and (b). The force–

displacement curve began to drop when the lateral force was around 850 kN in the 1st positive cycle of the 42 mm displacement ( $3D_y$ ). The specimen heavily buckled near the base of the wall. During the 1st negative cycle of the same displacement level, the recorded lateral force apparently decreased. The load had dropped to 500 kN when the lateral displacement was just over 30 mm. The test was terminated in order to prevent the damage to the test setup. The failure condition is shown in Fig. 6(c).

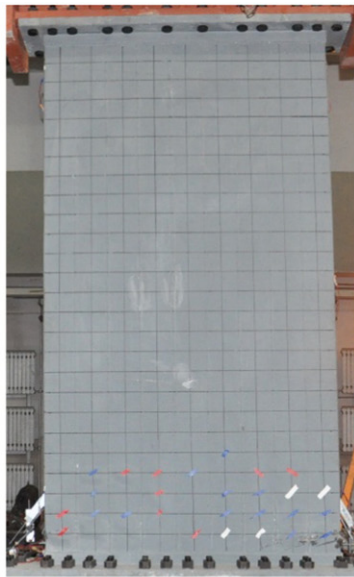
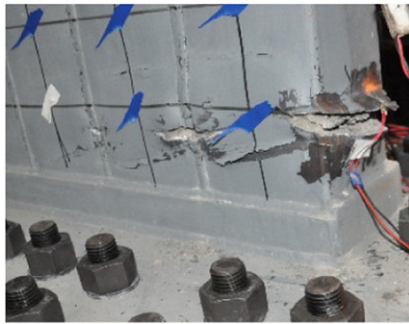
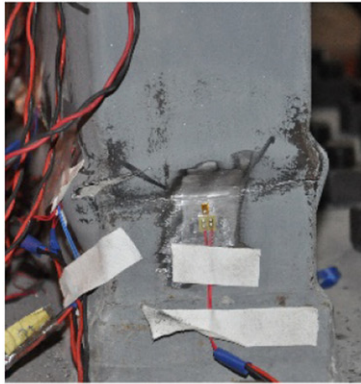
**Fig. 7.** Failure of Specimen -3. (a) Locations of labeled tapes. (b) Fracture propagation. (c) Small fractures observed.

(a) Locations of labeled tapes

(b) Fracture propagation

(c) Small fractures observed

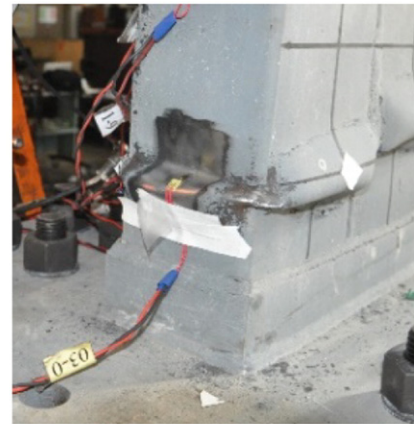
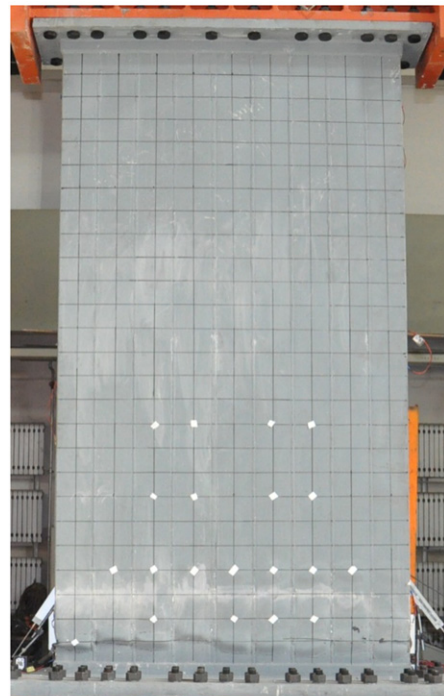
**Fig. 8.** Failure of Specimen -4. (a) Local buckling. (b) Buckling around the wall.

(a) Local buckling

(b) Buckling around the wall

buckling. At further cycles after the peak load, more buckling was observed (see Fig. 8(a)). At the 1st cycle of the displacement group of 45 mm ( $4.5D_y$ ), the lateral force decreased to 885 kN. The local buckling was extended to ten locations. During the 2nd cycle of the 45 mm, the load dropped to 753 kN. There was local buckling around the wall in the horizontal direction at the height of 150 mm up from the base, as can be seen from Fig. 8(b). The specimen was considered failed as the fracture that initiated from the corner ran through the depth of the specimen.

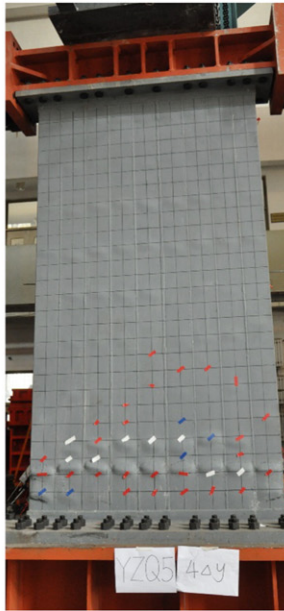
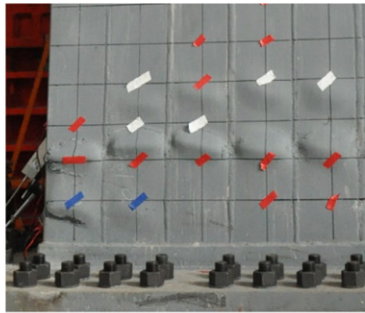
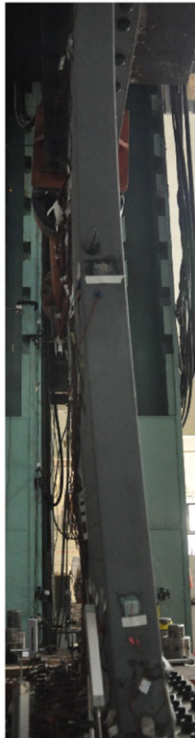
**Fig. 9.** Failure of Specimen -5. (a) Locations of labeled tapes and the failure condition. (b) Local buckling. (c) Out-of-plane deformation.

(a) Locations of labeled tapes and the failure condition

(b) Local buckling

(c) Out-of-plane deformation

For Specimen -5, the vertical load was applied in five stages. A slight sound was emitted from the specimen (the regions were labeled by blue tapes in Fig. 9(a)) when the axial force arrived at 4000 kN. The locations where the sound was heard under the axial force of 4350 kN were marked by red tapes. Out-of-plane deformation of 6 mm was observed after the vertical load was completed. The specimen still remained elastic before the horizontal displacement of 10 mm. In the loading group of 10 mm displacement, the specimen yielded but there was no sign of buckling on the wall. At the lateral displacement of

20 mm ( $2D_y$ ), the out-of-plane deformation increased to 12 mm. The deformation continued to grow up and reached 16 mm during the lateral displacement of 25 mm ( $2.5D_y$ ). Simultaneously, the channel at the boundary showed very slight buckling at 150 mm up from the base. During the displacement of 30 mm ( $3.0D_y$ ), the load arrived at its maximum value of 1236 kN. In the cycle of 35 mm displacement ( $3.5D_y$ ), the wall deformed 30 mm out of the plane at the height of 1350 mm. The existing local buckling at the height of 150 mm was aggravated and new buckling was observed at eight more regions. The most obvious buckling was observed 250 mm from the base as shown in Fig. 9(b). During the positive cycle of 40 mm ( $4D_y$ ) displacement, the lateral force dropped to 862 kN. The out-of-plane deflection at the height of 1300 mm increased to 51 mm. Buckling was observed at nine regions located at the height of 150 mm, 250 mm, and 450 mm. In the 2nd cycle as the lateral displacement reached 22 mm, the wall deformed out 73 mm at the wall center (see Fig. 9(c)). The horizontal load decreased to 80% of the peak load and the test stopped.

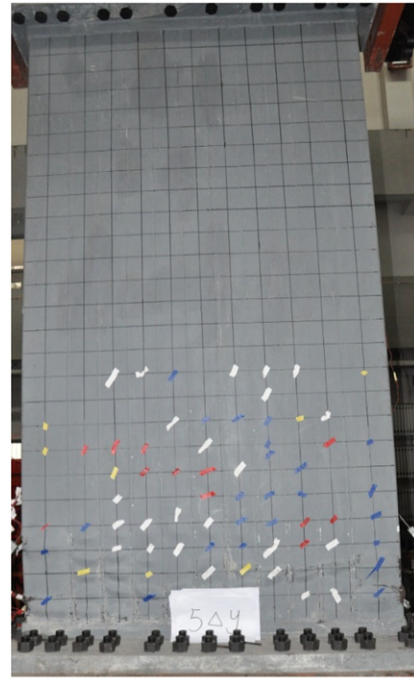
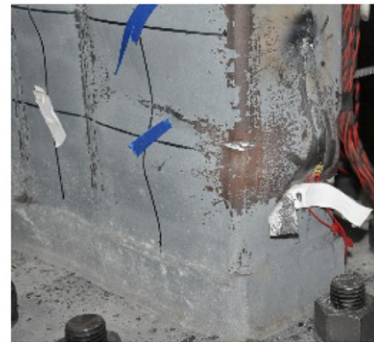
**Fig. 10.** Failure of Specimen -6. (a) Failure and the labeled location. (b) Local buckling.

(a) Failure and the labelled location

(b) Local buckling

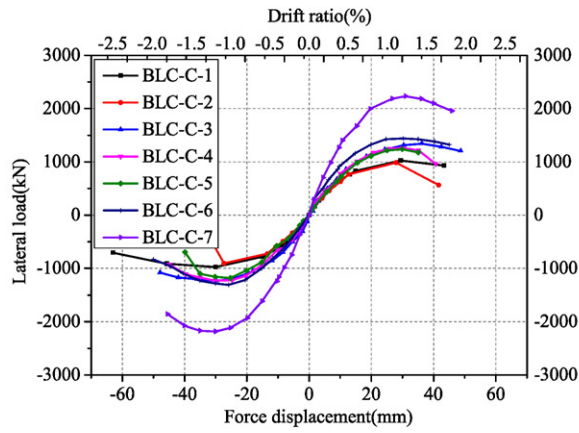
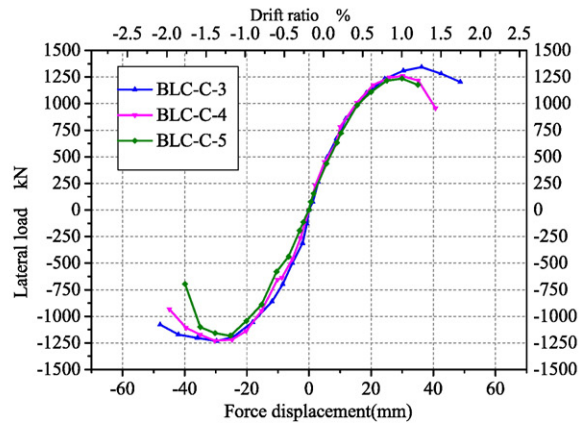
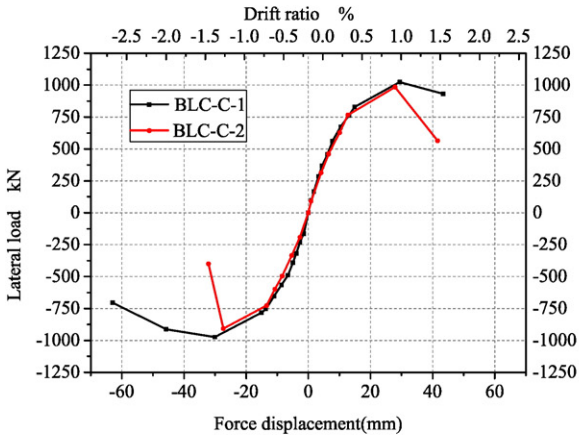
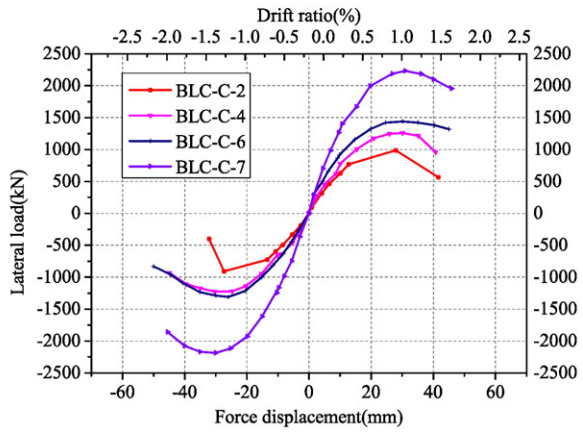
**Fig. 13.** Envelope curves of lateral force versus top displacement. (a) Curves for all specimens. (b) Comparison between Specimens -1 and -2. (c) Comparison among Specimens -3 through -5. (d) Comparison among Specimens -2, -4, -6, and -7.

(a) Curves for all specimens

(c) Comparison among Specimens BLC-C-3 through BLC-C-5

(b) Comparison between Specimens BLC-C-1 and BLC-C-2

(d) Comparison among Specimens BLC-C-2, BLC-C-4, BLC-C-6, and BLC-C-7

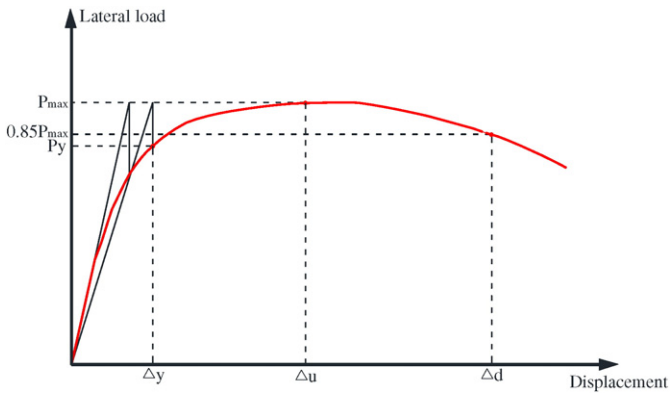
Fig. 14. Determination of yield strength.

Hysteresis loops were expected to increase their displacement range at further cycles. When the force during the following cycle exceeds the peak load on the previous cycle, the exceeding portion of the loop during the following cycle is connected to the point at the peak load of the previous cycle. The same process is repeated until the failure point is reached. In this procedure, an envelope curve was defined and constructed for each of the positive and negative loading directions as given in Fig. 13. The test value obtained for initial stiffness, yield load and peak load are summarized in Table 3. The method to determine the yield strength of the specimen is illustrated in Fig. 14.

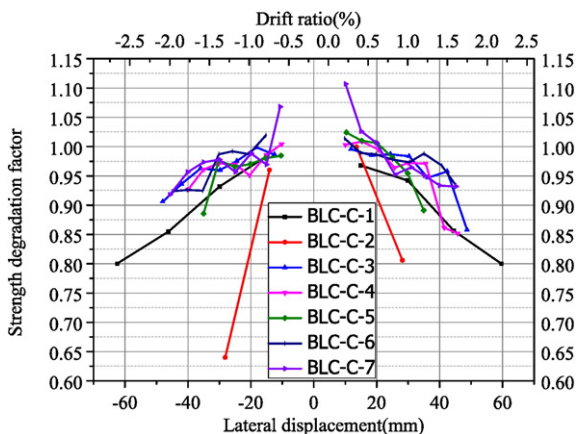
Fig. 15. Strength degradation of specimens.

Fig. 15 plots the values of  $\eta_i$  at different displacement levels for all specimens. It can be observed that  $\eta_i$  gradually decreases with the increase in the displacement level. The strength deterioration is more noticeable as the further cycles progressed. Before the peak load is reached,  $\eta_i$  generally ranges from 0.90 to 0.95 for Specimens -1 and -2 and from 0.95–1.0 for the rest of the specimens, and occasionally exceeds 1.0 for the deviation of measurement, which indicates moderate strength degradation before the maximum strength point. After the peak load is achieved, the strength degradation is more severe and evident.  $\eta_i$  decreases to 0.8 for Specimen -1 and 0.9 for Specimens -3 to -7.

$\eta_i$  is even below 0.65 for Specimen -2 during the negative loading cycles. This is because the highest axial ratio ( $=0.7$ ) is applied to Specimen -2, which induces the largest deformation at the same displacement level. More severe and intensive local buckling was observed during the test in Specimen -2 than in other specimens by the end of the 3rd cycle in the displacement of  $2D_y$ , which results in more severe strength degradation. Specimen -6, with the relatively reinforced boundary element, shows much more gradual strength deterioration than the other specimens.

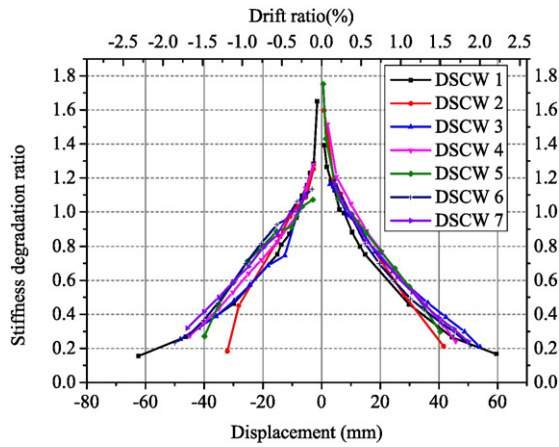
Fig. 17. Stiffness degradation ratio versus top displacement response.

The  $K_i$ - $d$  curves and  $\xi$ - $d$  curves of all specimens are shown in Fig. 16 and Fig. 17, respectively. The cyclic stiffness degradation responses are compared, and the following observations can be made:

observed among specimens with various axial load ratios. Stiffness deterioration is more stable and gradual in Specimen -3 than in Specimens -4 and -5. The same observation can be found in the comparison between Specimens -1 and -2. This demonstrates that lower axial force ratio offers more stable stiffness degradation pattern.

2. Considerable reduction in stiffness is observed in all specimens as larger lateral displacement is imposed. At the ultimate displacement level, the ratios of the cyclic stiffness to the calculated initial stiffness

for all specimens range from 0.15 to 0.32. It should be noted that before the specimen yields, stiffness degradation  $\xi$  for some specimens unexpectedly exceeds 1.0. This is because the initial stiffness  $K_0$  is calculated from the ratio of the averaged lateral load to the averaged lateral displacement before the yielding of the specimen to alleviate the deviation of measurement. At a small displacement level, the calculated stiffness may noticeably differ from its actual value as a relatively large measure deviation.

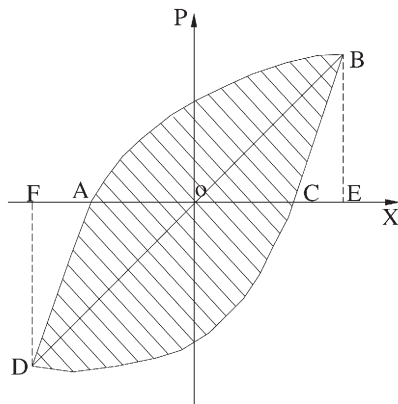
Fig. 18. Equivalent damping coefficient calculation diagram.

As expected, the energy dissipation of the specimen, which can be identified as  $S_{(ABC+CDA)}$ , gradually increases by increasing the displacement amplitudes of the hysteresis loops up to the failure point. Specimen -2 exhibits the poorest energy dissipating capacity. Although the energy absorbed per cycle by Specimen -2 is similar to that by the other specimens, the least hysteresis cycles were observed in Specimen -2. Therefore, the cumulative energy dissipated by Specimen -2 is the lowest. The best cumulative energy dissipation capacity is found in Specimen -7. The deformation capacity of Specimens -6 and -7 is similar; the latter however, possesses greater strength than the former, which indicates that the latter has a larger cumulative energy dissipation capacity.

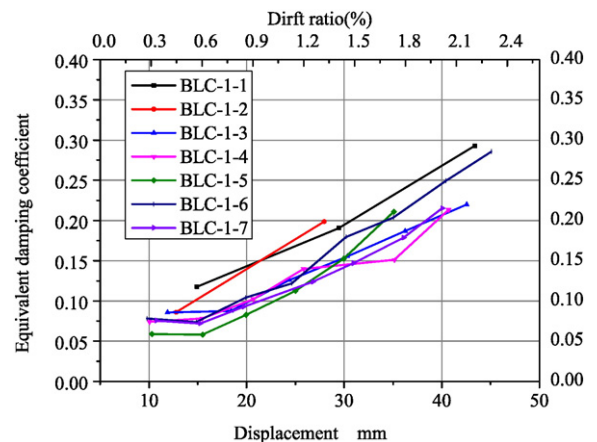
Fig. 19. Energy dissipation.

identified by Eq. (6). The results are presented in Table 4, and the  $h_e-\theta$  curves of the specimens are shown in Fig. 19.

The equivalent damping coefficient stably goes up with the increase in the displacement level. It stays at a low level of around 0.5 before the
