Cyclic behaviour of Y-shaped eccentrically braced frames fabricated with high-strength steel composite

Feng Wang^a, Mingzhou Su^{a,*}, Min Hong^b, Yirong Guo^c, Shaohua Li^b

^a School of Civil Engineering, Xi'an University of Architecture and Technology, 13 Yanta Road, Xi'an 710055, PR China

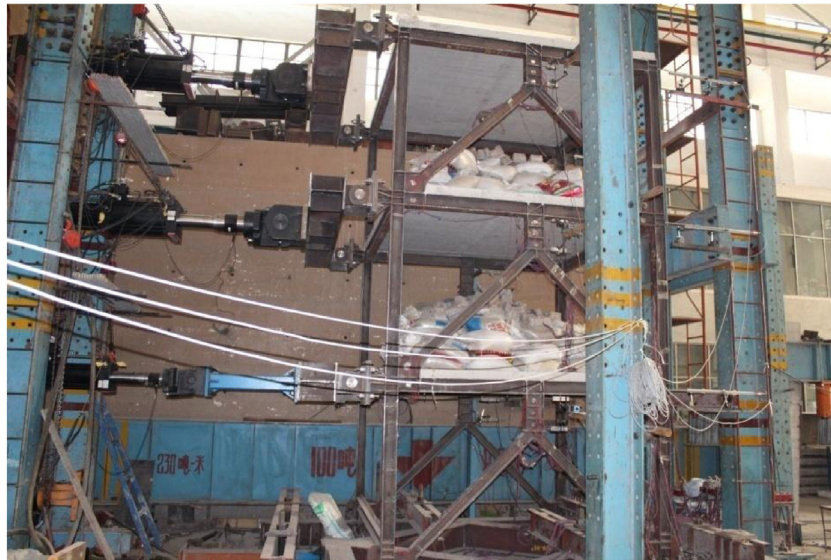
(a) Schematic

(b) Photo

Fig. 6. Test structure and instrumentation (LVDT: linear variable displacement transducer).

Fig. 6 illustrates the general arrangement of the experimental setup. The specimen was bolted to six rigid foundation steel grinders, which in turn were restrained by two strong steel beams to prevent the frame specimen from lifting during testing.

Two 1000-kN and one 500-kN servo-actuators were used to apply low-cyclic horizontal loading on the Y-HSS-EBFs through the rigid loading beams. The load proportions of the three load points were maintained at 3:2:1 from top to bottom as determined by the base shear method. Instrumentation including load cells was used to measure the reactions and applied actuator force.

The behaviour of the boundary frames and links during the testing was measured. Fig. 6 shows the measuring instruments. The horizontal displacement of the column-to-beam connections for each storey were measured with six linear variable displacement transducers (LVDTs), and the relative displacement between the frame base and rigid steel beam were measured with two dial gages. To get the principal stresses of the specimen, rosette and uniaxial strain gauges were installed in some higher-stress areas (e.g. link web, link flange, link-to-beam connections, column-to-beam connections, column footing).

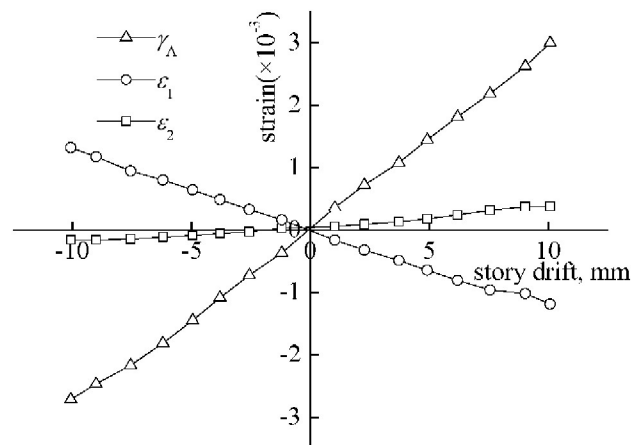
Fig. 14. Strain–storey drift skeleton curves.

web and link flange are shown in Fig. 13. The link moments can be obtained by the material mechanics formulas $\sigma = My / I_z$ and $\sigma = E\varepsilon$ in the elastic range. Therefore, the link moments near the storey beam and adjacent to the braced members can be approximated as $M_A = E_f \varepsilon_1 I_z / y$ and $M_B = -E_f \varepsilon_2 I_z / y$, where E_f is the elastic modulus of the link flange, I_z is the section moment of inertia, y is half of the link height, and ε_1 and ε_2 are the values of uniaxial strain gauges No. 1 and No. 2, respectively. The link shear can be given by the formulas $\tau = (FS) / (I_z d)$ and $\tau = G\gamma$ in the elastic range, and the link shear near the storey beam can be approximated as $F_A = G_w \gamma_A I_z d / S$, where G_w is the shear modulus of the link web, d is the web thickness, S is the static moment of half of the link section, and $\gamma_A = \varepsilon_3 + \varepsilon_5 - 2\varepsilon_4$ is the shear strain of point A. Fig. 14 shows the strain–storey drift skeleton curves. Some of the rosette and uniaxial strain gauges failed during the displacement-control loading stage; thus, only the values of the force-control loading stage are given (see Fig. 14). The link moments were proportional to the link flange strain at the corresponding positions, and the differences between ε_1 and ε_2 and between M_A and M_B gradually increased with the lateral load (see Fig. 14). According to the force-balance principle ($\sum M = 0$), the link moments and link shear have to satisfy the relationship $M_A + M_B + V_A e_1 = 0$, where $e_1 = 0.25$ m was the distance between the first and third rosette strain gauges along the link. By substituting the values of the strain gauges at the lateral load of 240 kN in the above equations, the relationship $M_A + M_B + V_A e_1 = 10.70 + 1.22 - 46.39 \times 0.25 = 0.32 \approx 0$ was basically satisfied. Towards the end of the force-control loading stage, the uniaxial strain gauge No. 4 reached the yield point strain, and the test load entered the displacement-control stage. This experiment result showed that the combined action of the link flange moment near the storey beam and the large shear load of the link web probably produced the beam flange fracture in frame 1 of the first storey, and the links in the first storey were mainly subjected to shear and flexural failure.
