# On the delamination phenomenon in the repair of timber beams with steel plates

Giovanni Metelli\*, Marco Preti, Ezio Giuriani

Department of Civil, Environmental, Architectural Engineering and of Mathematics, University of Brescia, Italy

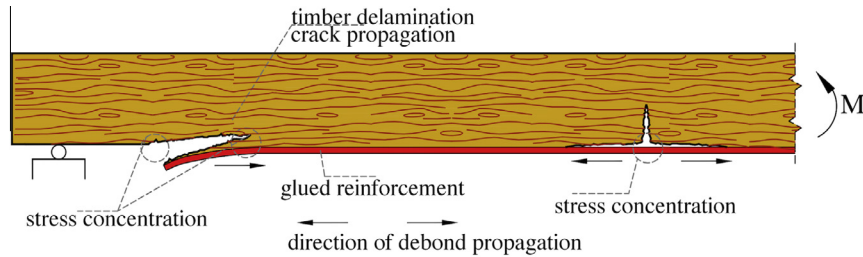
Fig. 2. Delamination of the timber near the glueing surface at plate ends or at midspan close to defects and cracks.

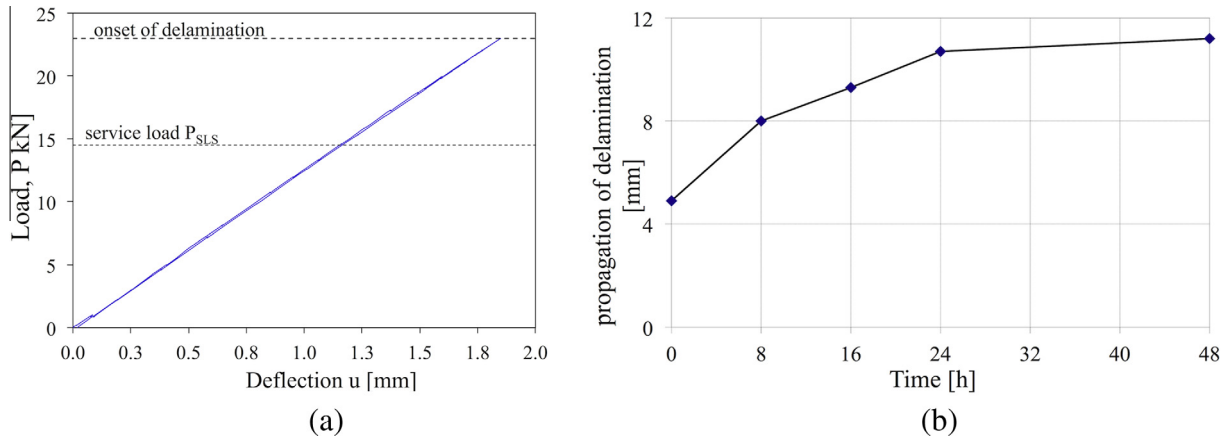
The global response of the tested repaired beam is described by the load–deflection curve (Fig. 9a). Five cycles were applied up to the service load ( $P_{SLS}$ ) of 14 kN and then the load was increased up to the onset of the plate delamination. A linear elastic behaviour can be noted up to the plate delamination when the test was interrupted.

In Fig. 10a and b the Moiré interference effects for a load  $P = 0$  kN (initial mismatch) and for a load  $P = 22$  kN are shown. Fig. 10c shows the discontinuity of Moiré fringes for the load  $P = 23$  kN, for which the onset of the delamination occurred at the left end of the plate placed on the beam's back side (labelled with position BL in Fig. 7). Finally, the load was kept constant at the peak value of 23 kN to monitor the propagation of the plate delamination. It rapidly moved forward within the first 8 h up to the distance of 8.0 mm away from the plate end at a rate of about 0.37 mm/h, while it stabilised after 24 h with a debonded length of 11 mm (Fig. 9b).

Fig. 9. Test results: beam deflection (a); propagation of plate delamination (b).

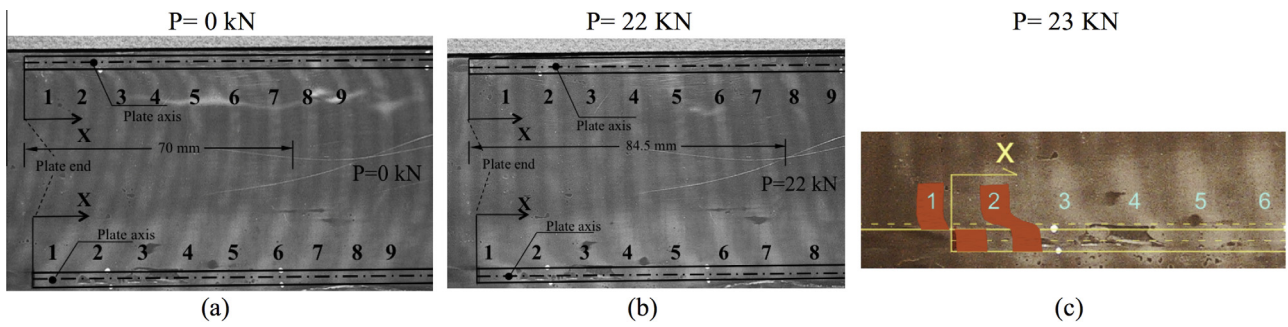
Fig. 10. Moiré interference effects for a load  $P=0$  kN (initial mismatch) (a), for  $P=22$  kN (b) and for the load  $P=23$  kN for which the plate delamination occurred (c).

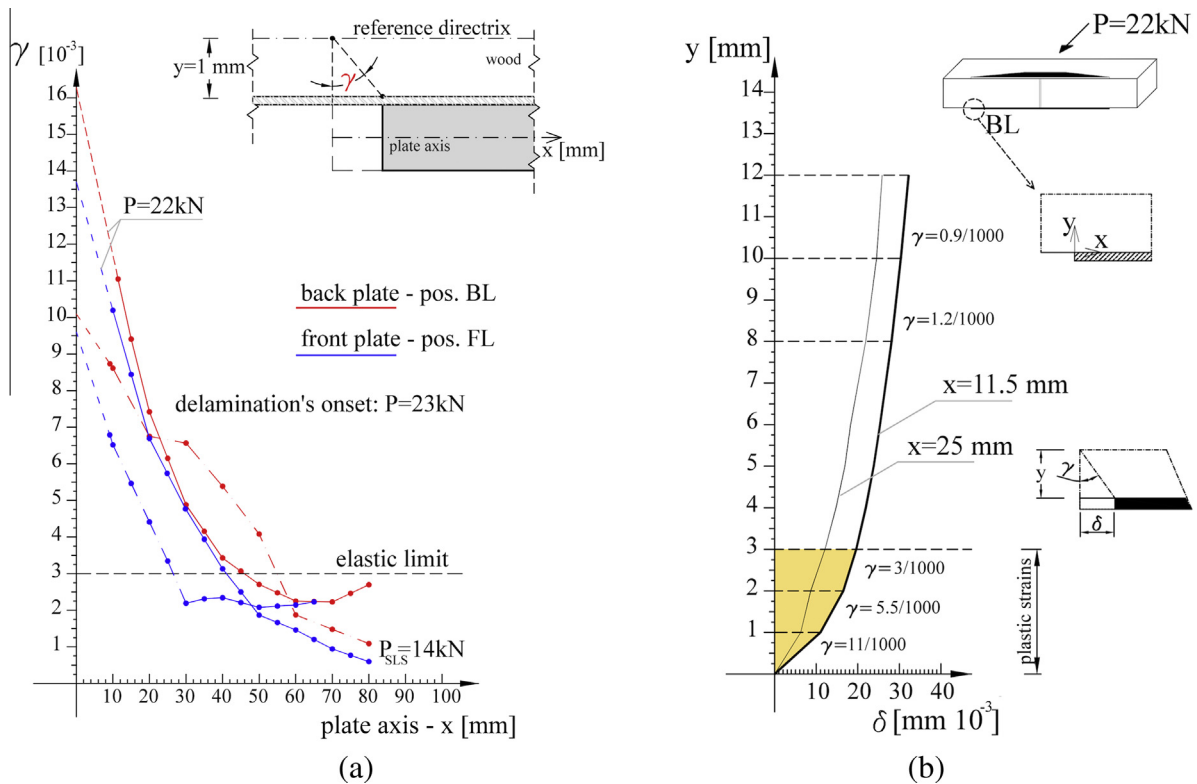
With regard to the wood strain measured using the Moiré technique, the results around the region at the left end of the back plate, where the delamination occurred (position BL/FL in Fig. 7), are presented. Further details of the measured wood strains close to the plate ends and to the notch at the beam midspan can be found in [30]. In Fig. 11a the shear strains of the wood evaluated along the longitudinal directrix ( $x$ ) at a distance of 1 mm from the glued surface (as shown in Fig. 8) are plotted for increasing values of the applied load ( $P$ ). For a load  $P = 22$  kN, before the plate delamination occurred, the test results showed a remarkable value of the shear strain ( $\gamma = 16 \times 10^{-3}$ ), far beyond the elastic limit ( $\gamma_{el}$ ) of about  $3 \times 10^{-3}$  provided by the results of local shear tests on sapwood which can be found in the literature [31,35]. Furthermore, the shear strain of the wood remains in the elastic range ( $\gamma < \gamma_{el}$ ) for a distance greater than 70 mm from the plate end.

In Fig. 11b the slip ( $\delta$ ) between the back plate's axis and the timber layer at distance ( $y$ ) from the glued surface is plotted for a distance  $x = 11.5$  and 22 mm from the left plate end at a load  $P = 22$  kN

Fig. 11. Test results: wood shear deformation ( $\gamma$ ) at the left plates's end evaluated at a distance equal to 1 mm from the timber–glue interface (a); slip ( $\delta$ ) between the plate and the timber fibres at a distance  $x = 11.5$  or 22 mm from the left end of the back plate (position BL) (b).

(slightly lower than the delamination load  $P_D = 23$  kN). It should be noted that the zone with a non-linear shear behaviour was localised in a very limited area, not farther than 3 mm from the glue-timber interface and that the stress diffusion effects fade out at a distance of about 10 mm from the glued surface.

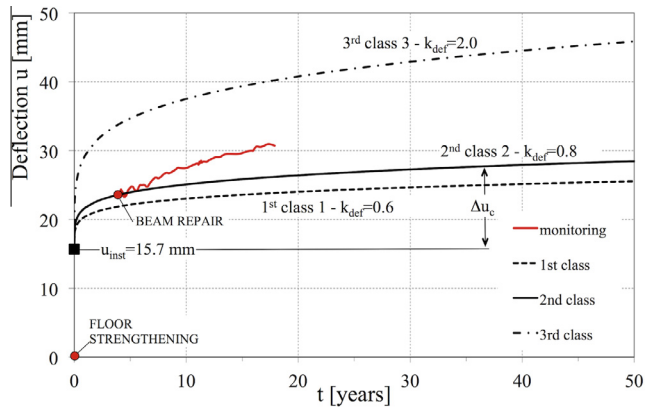
**Fig. 14.** The increase of midspan deflection with time of the timber-to-concrete composite beam: comparison between monitoring data (averaged value) and the long-term prediction according to Eurocode 5 [29].

In order to prove the important creep effect on floor deflection, the estimated final creep deflection increment ( $\Delta u_{c,\infty}$ ) for a quasi-permanent combination of action (Eq. (6)) is shown in Figs. 13a and 14. The creep deflection is calculated with the simplified approach proposed in Annex B of Eurocode 5 [29] for composite beams with flexible connections. Similar accurate results can be obtained also by means of an exact relationship between the slope increment of the beam end and the maximum concrete–timber slip at the support [38–40]. The calculation is carried out by assuming a simple-supported beam, a linear elastic behaviour of all components (timber, concrete, connection), a modulus of concrete  $E_c = 31470$  MPa [41], a modulus of elasticity of the wood  $E_w = 11500$  MPa [25], a timber-to-concrete connection stiffness  $K_S = 22700$  N/mm as proposed by Gelfi et al. [1] for connection with 16 mm stud diameter.

Finally, in Fig. 14 the trend of the predicted beam deflection over 50 years is shown for different environmental conditions. The trends in time of the beam deflection were qualitatively
